Tips from Comanche *Flyer* magazines Feb 1973 – Sep 2012

CHAPTER THREE

FUEL SYSTEM

(FUEL TANKS, FUEL LINES, TIP TANKS, GAUGES

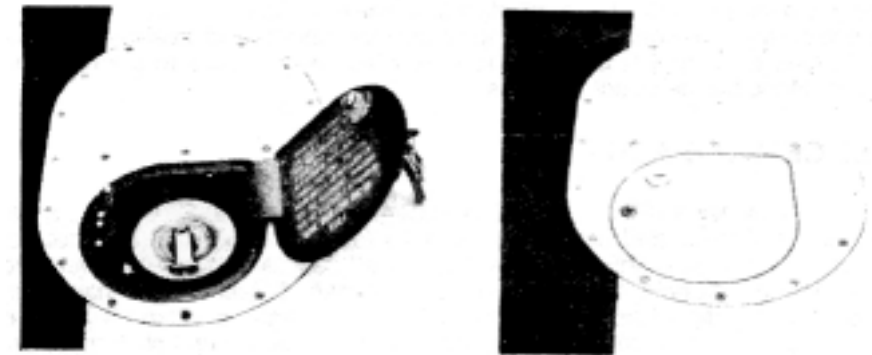
Fuel Cell Door Locks

Somebody a while back inquired about locks on fuel tanks and the enclosed pictures may be helpful. I paid \$4.50 each for two locks at a Locksmith and the shop time for installation was about 3 hours. The installation was done by Alair Aviation at Aurora, OR.

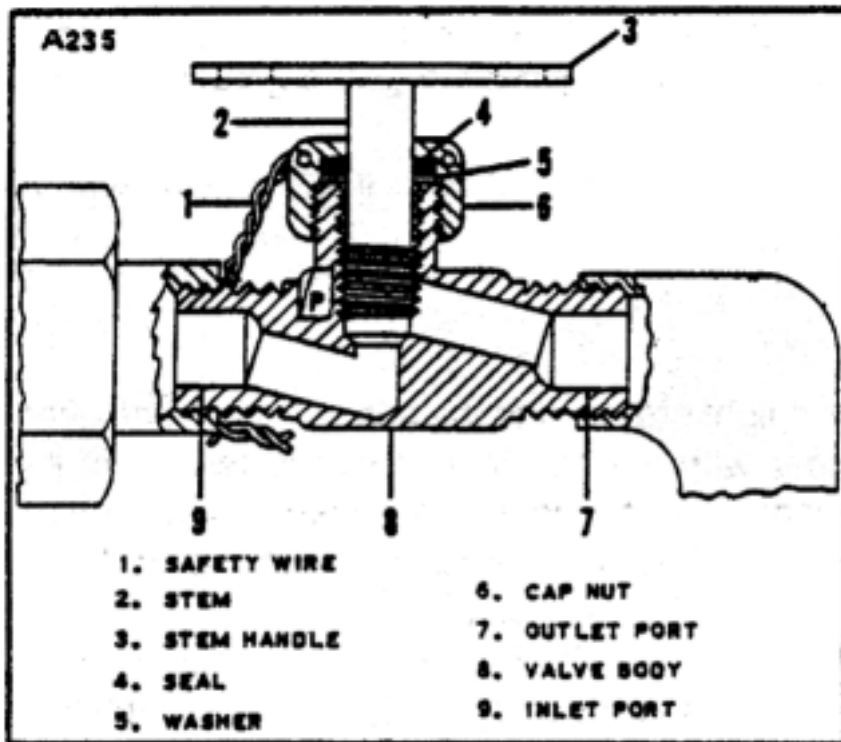
Diagram A235[above], is taken from Twin Comanche Service Manual, Heating and Ventilation Section

Item "C" of the service manual states to inspect the stem, seat body and threads for possible damage. On our valve we found that the shaft was dirty from years of service and when opened allowed the shaft to enlarge the seal (4). The stem was cleaned with MEK and Scotchbrite, lubed and returned to service. The valve is now operating correctly and not leaking.

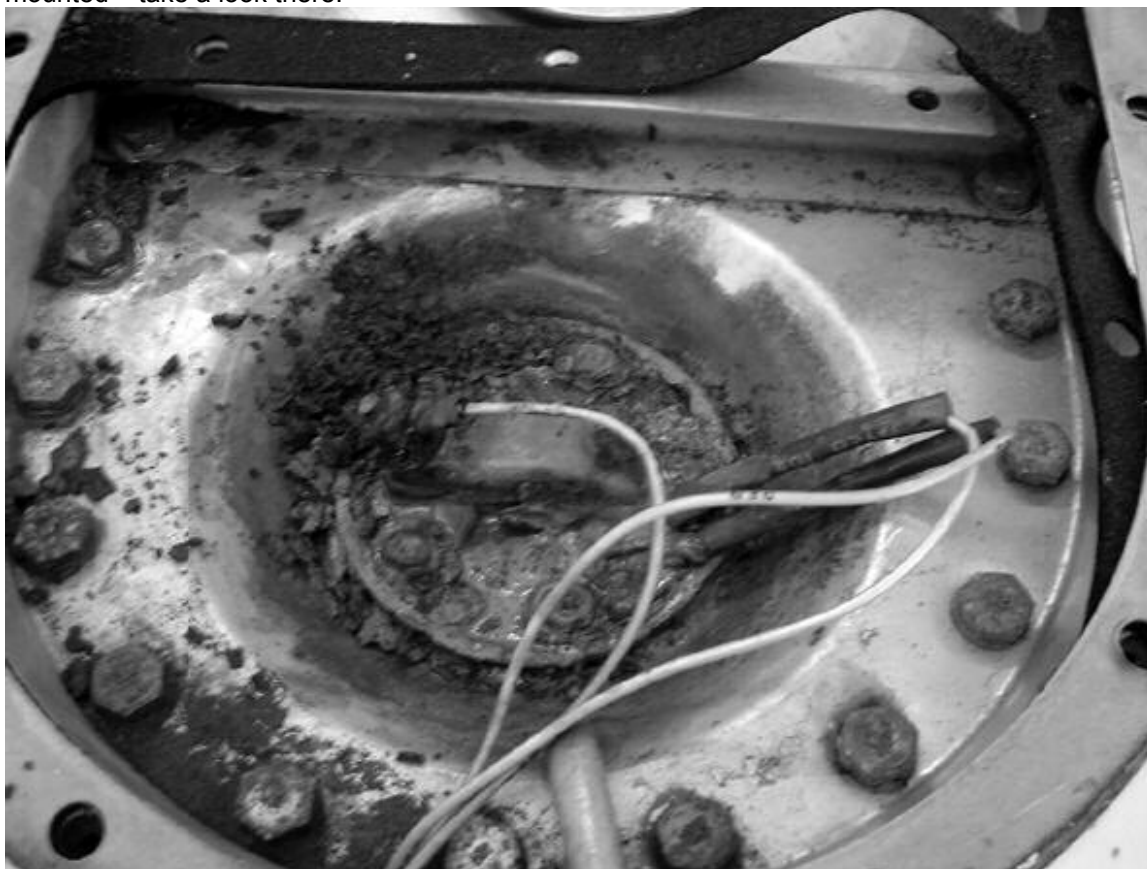
This main tank transmitter didn't survive due to the extensive corrosion.

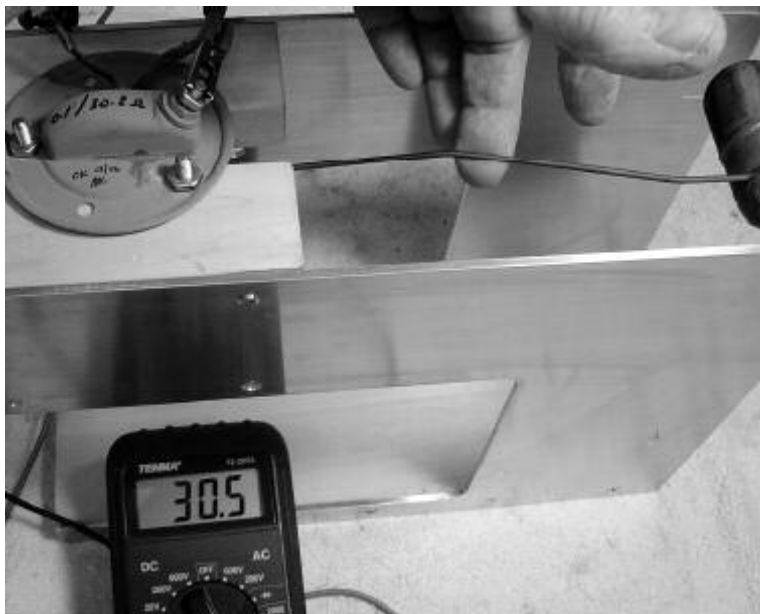
This wiper button is okay, even with the small spot that has worn.

Another cause is internal to the transmitter – a dirty resistance winding (not obvious) inside a fuel transmitter is quite common and easy to check. The internals of the transmitter are simple and diagnosis and repair fairly simple once disassembled. There are cases however where the fuel level transmitter has reached the end of its life, i.e. the wiper button is too worn, broken or missing, or excessive housing corrosion.

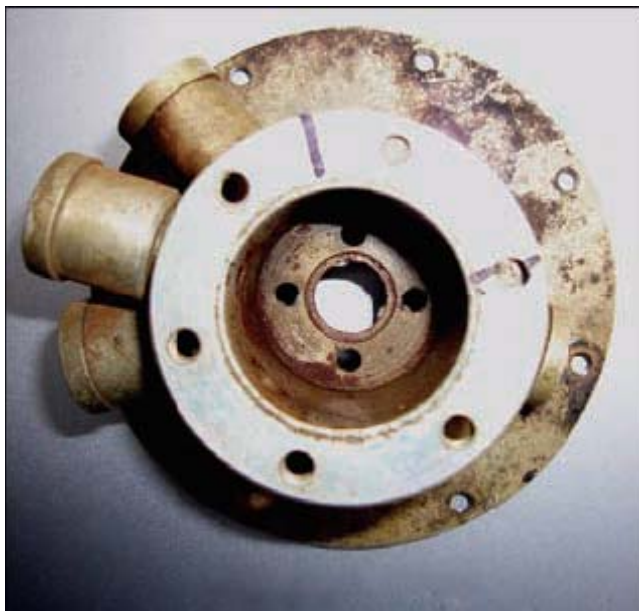
What I discovered was that the design of the valve body traps moisture that is not drained during normal pre-flight, or even when drained using the mandated procedure which calls for 10-25 seconds of draining per tank. This water had, in turn, caused rust to form in the divider area between the upper and lower chambers of the valve. Fortunately for me, my selectors were not as badly corroded as the one shown in the photograph.

Corroded fuel selector body

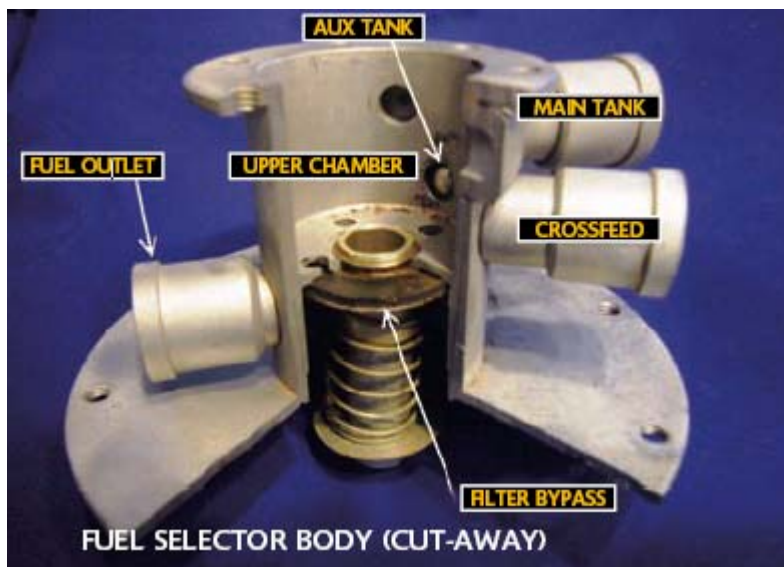
It is easy to tell from the cut-away photo, that the design of the divider between the upper and lower chamber has a tendency to trap droplets of water both above the divider and on the lower side of the divider, between it and the seat of the bypass valve. Sooner or later, the droplets of water will overcome the cadmium plating on the selector body, and rust will form.

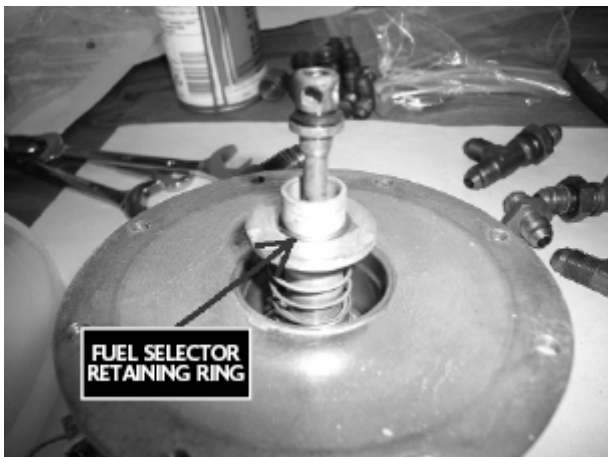
The two ADs should also be performed religiously at 50-hour intervals, as required. It is probably a good idea to perform the ADs at least once every six months, if the aircraft is not flying frequently. When removing the fuel bowl to clean the filter as required by AD 83-10-01, I go one step further. After removing the fuel filter, I remove the little clip holding the bypass valve spring in position (see photo.)

This allows me to remove the retaining washer, spring, and the bypass valve itself. Then I place a pail or other catch basin under the selectors and get into the aircraft. By switching the selector from OFF to MAIN, the AUX, and the Crossfeed, for each tank, I drain fuel through the bypass, as well as the normal pathway. This, I hope, will help flush some of the water droplets which seem to accumulate above the divider between the upper and lower chambers and the water trapped between the bypass valve and underside of the divider. I have not figured out how to test this technique, so I don't know if it offers significant benefit. At least the effort is very modest.

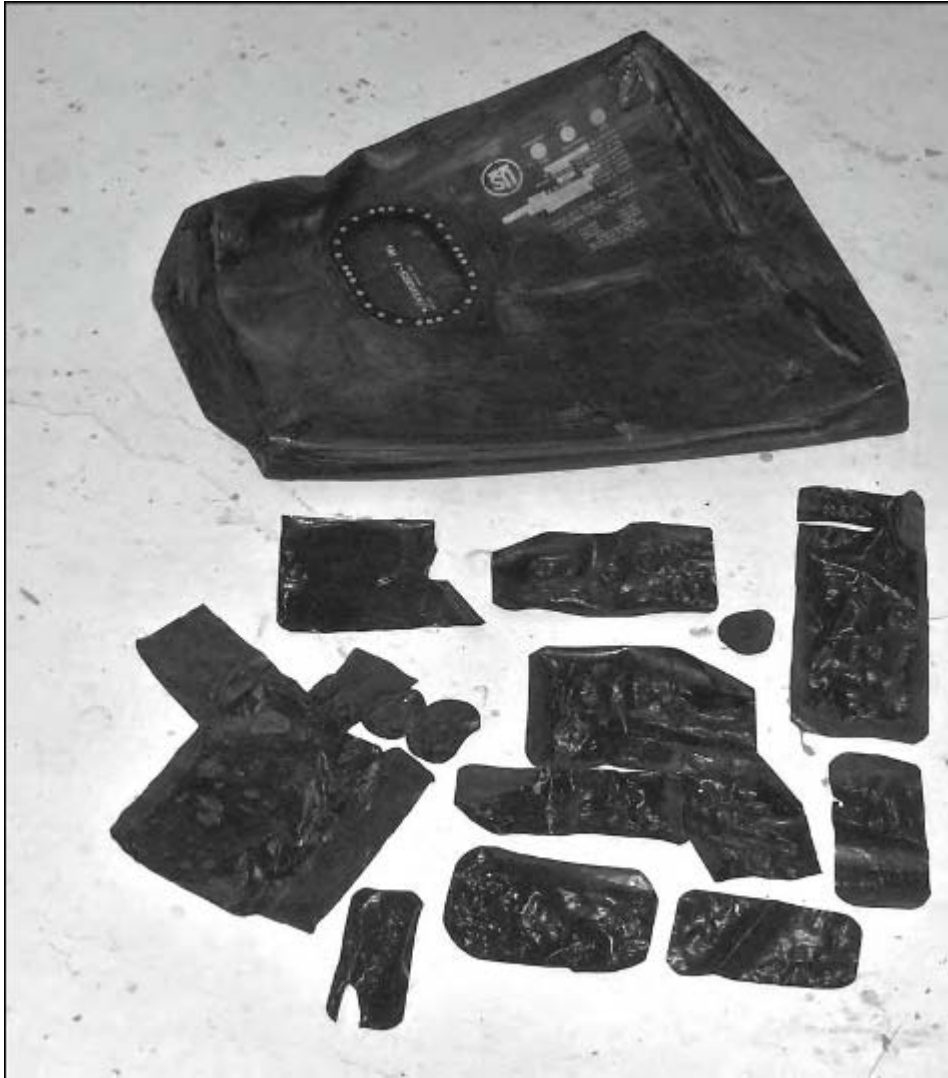
The photo shows one of the fuel cells and the fifteen patches that it contained. There were patches on the patches! The other fuel cell wasn't any different.
