TIPS – Chapter Three

Fuel System

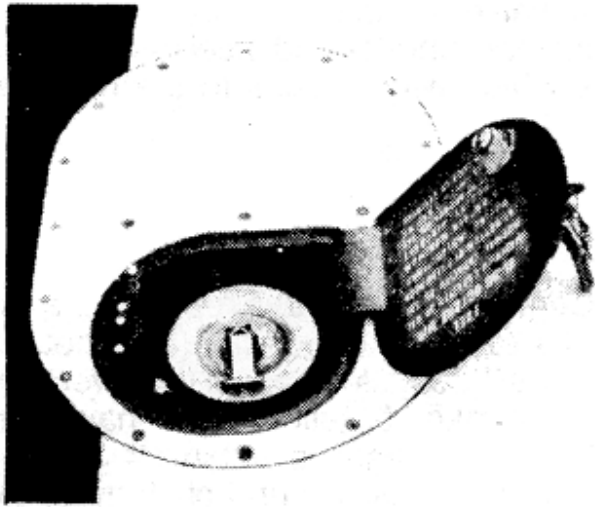
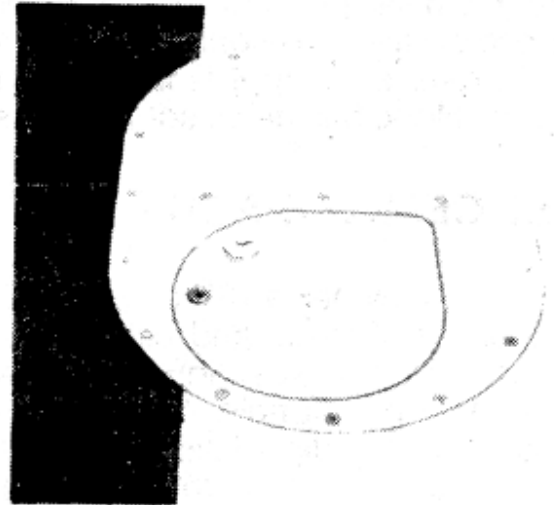
FUEL CELL DOOR LOCKS

Somebody a while back inquired about locks on fuel tanks and the enclosed pictures may be helpful. I paid \$4.50 each for two locks at a Locksmith and the shop time for installation was about 3 hours. The installation was done by Alair Aviation at Aurora, OR.

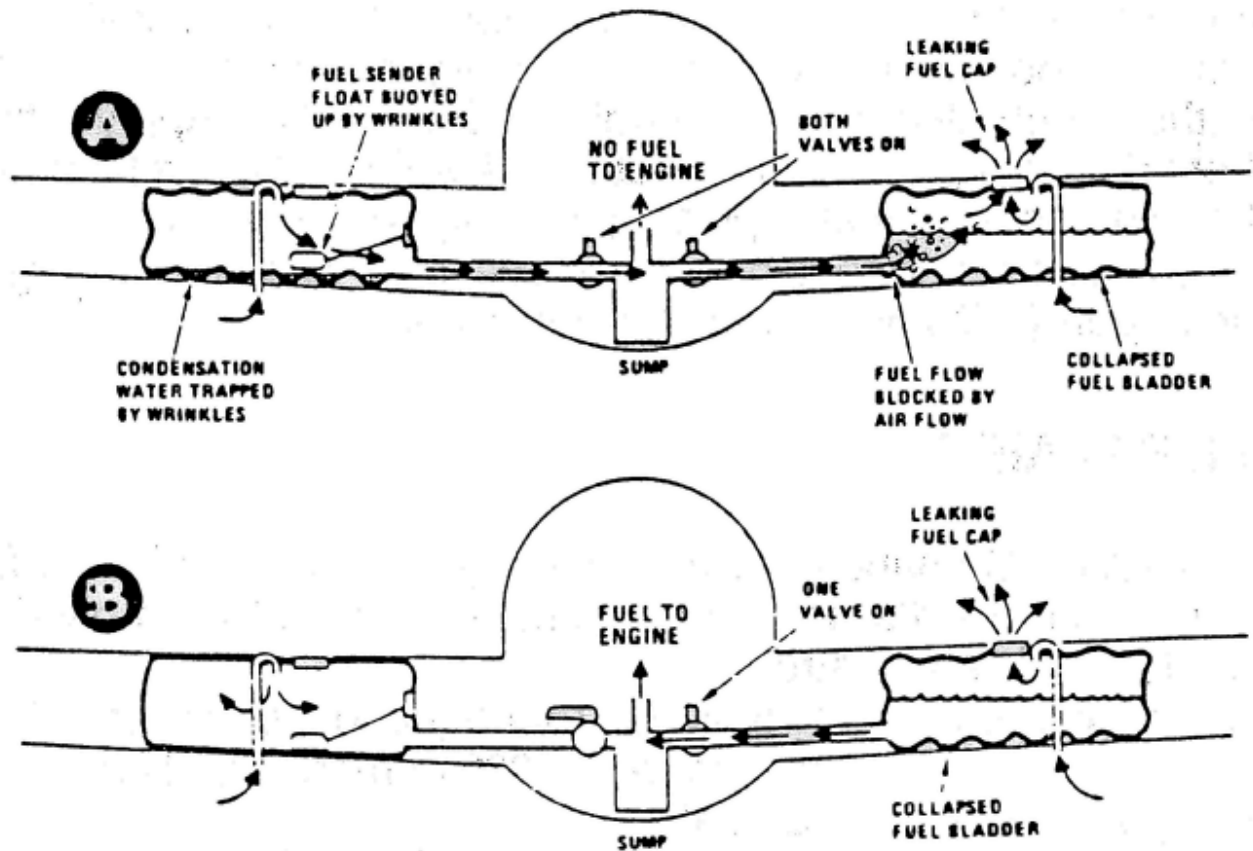
I suspect leaking fuel caps is the only way the wrinkles could have formed in the fuel cells. After fixing the leaking caps, the wrinkles completely disappeared. It should be noted that improperly installed caps by an inexperienced line boy could also create this problem. I now make it a policy to fly on only one tank at a time - ESPECIALLY DURING TAKEOFFS AND LANDING. Even if you were using a tank with a leaking cap and collapsed cell, the fuel would still flow into the sump - just as long as it were not blocked by air coming from another tank.

I have never had this happen in all my combinations and I suspect the tanks are pretty much equally pressurized. This is possibly what the AD on the main tanks on Comanches (to install larger intake ports) was all about but more than likely it was brought on by the leaking cap problem.

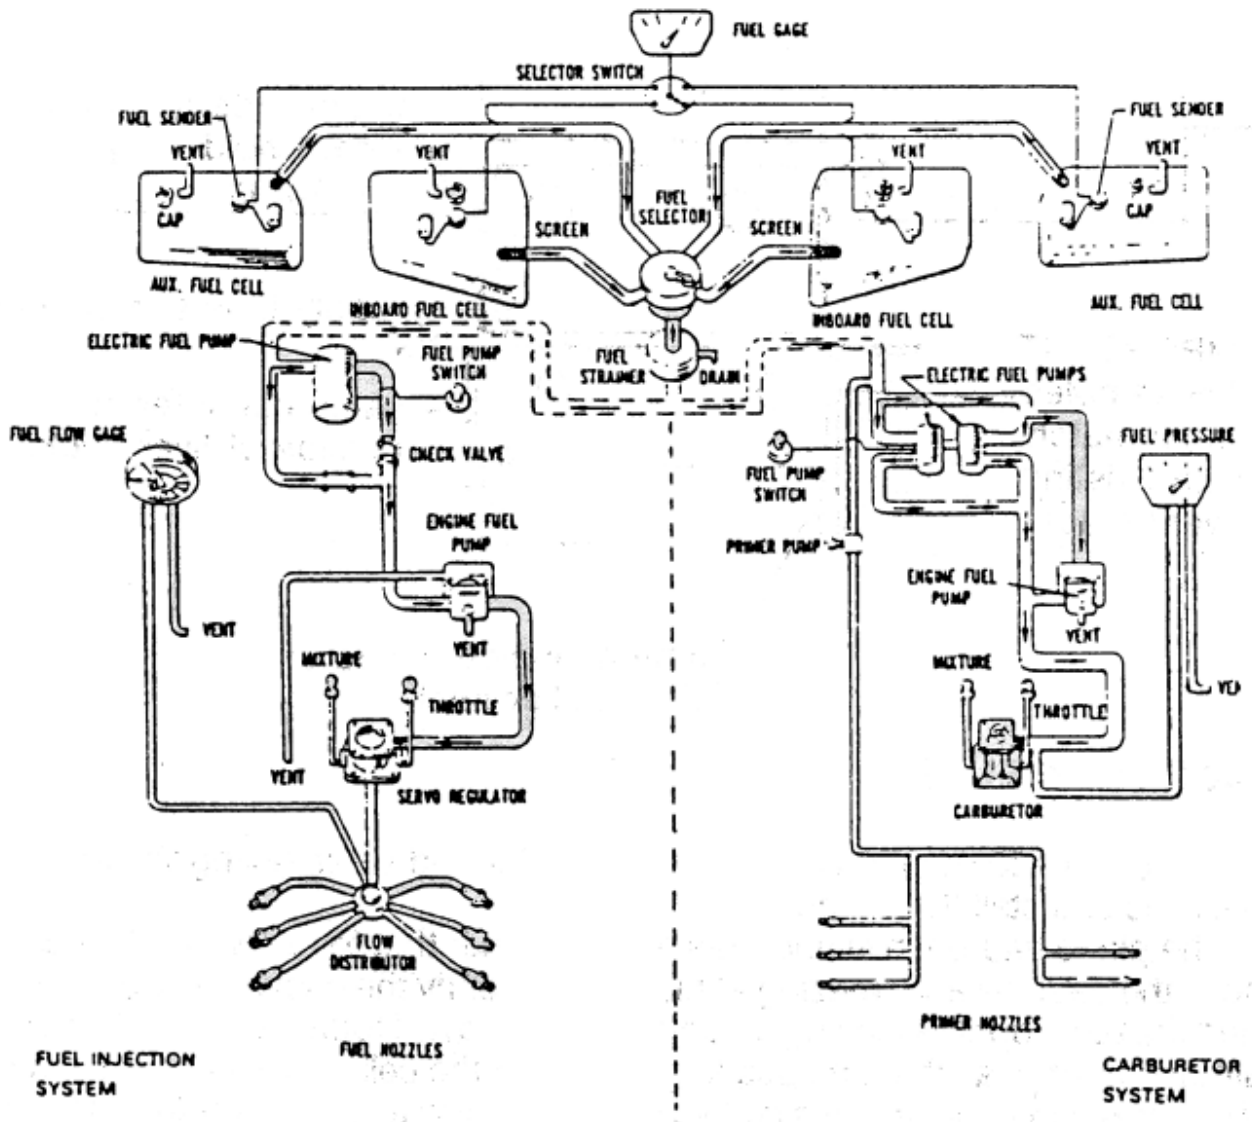
A typical Comanche fuel line schematic. Carb. models could suffer excessive fuel heat and vapor build-up in engine-driven pump and its lines when electric pumps are operated for long periods.

In my opinion, this method will prevent the very large drop or the temporary loss of fuel pressure when the electric pump is turned off after being on a long time on the ground plus a long time to altitude. However, there will be some drop in full pressure when the electric pump is turned off but no interruption of fuel flow should occur.

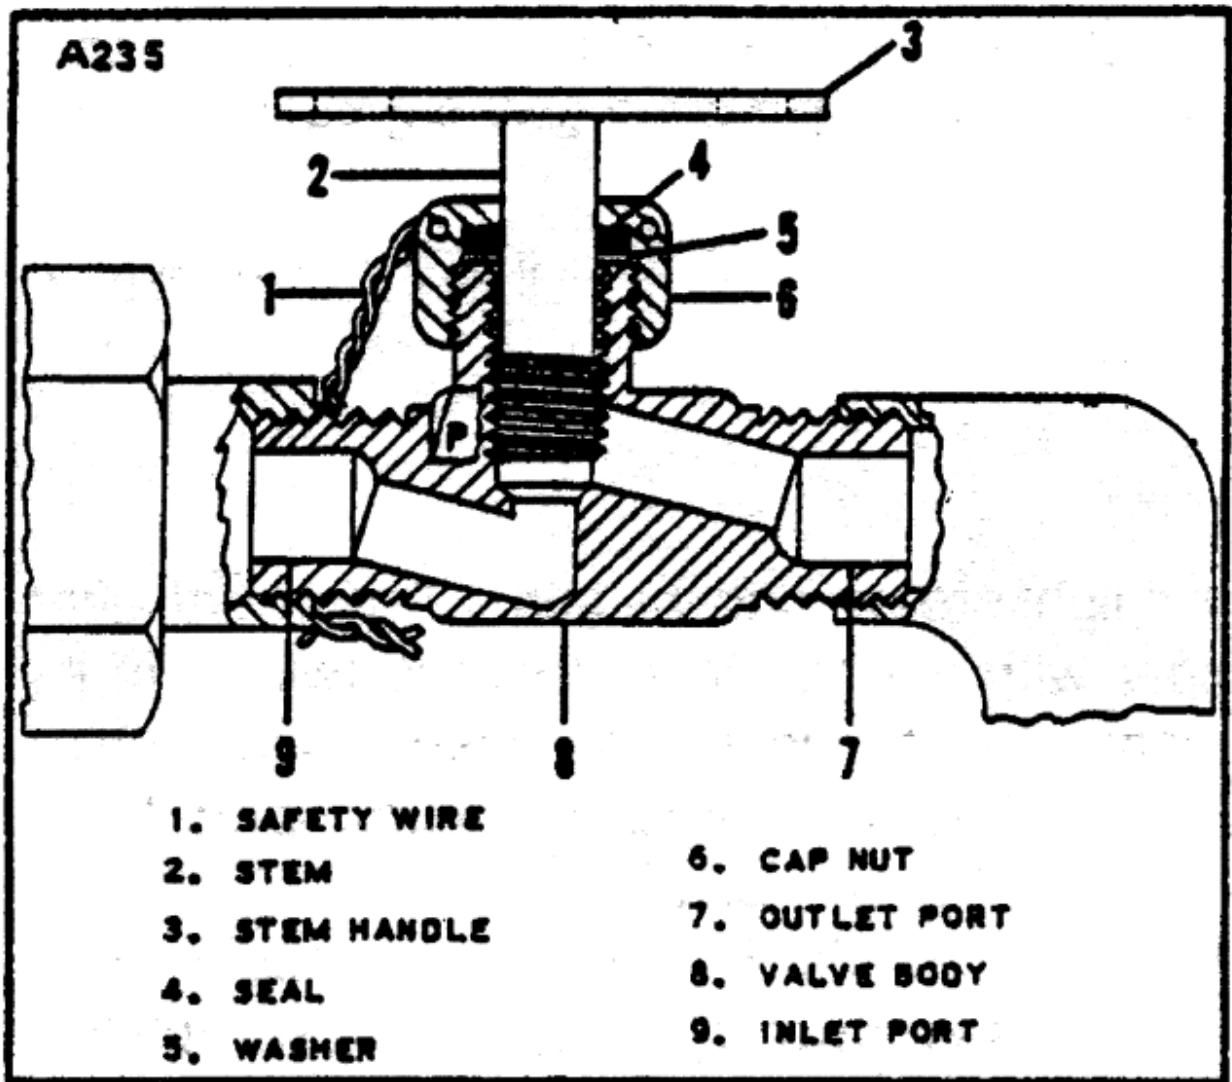
Diagram A235[above], is taken from Twin Comanche Service Manual, Heating and Ventilation Section

Item "C" of the service manual states to inspect the stem, seat body and threads for possible damage. On our valve we found that the shaft was dirty from years of service and when opened allowed the shaft to enlarge the sea[(4). The stem was cleaned with MEK and Scotchbrite, lubed and returned to service. The valve is now operating correctly and not leaking.

If any fuel is observed valve must be repaired or replaced.
