TIPS – Chapter Seven

Landing Gear and Brakes

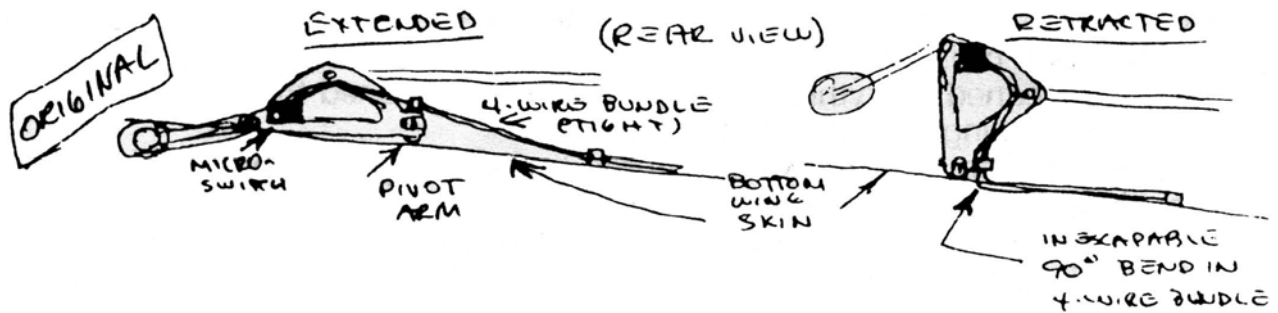
I've wanted to send you a note on the PA-30 landing gear microswitch wiring – we had a broken wire on left main where the 4 wire bundle had to bend due to gear retraction, VIZ.

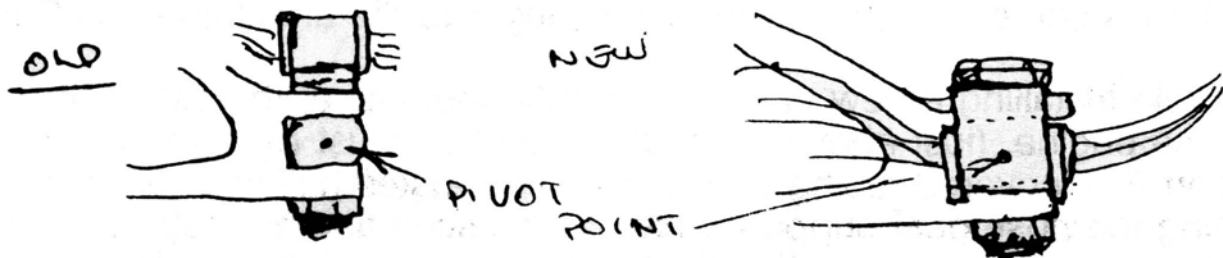
The cable clamp at pivot arm if factory positioned – holding cable about 1 1/2" away (radius) from pivot point. The result has to be a large transverse motion of the bundle as the gear retracts. My solution: Reverse the position of the 4 bundle clamp on pivot arm as follows:

This reduces the transverse distance the clamp (ergo-bundle) has to travel to about 1/4" more / less. Basically, the clamp now rotates only instead of rotating and traveling.

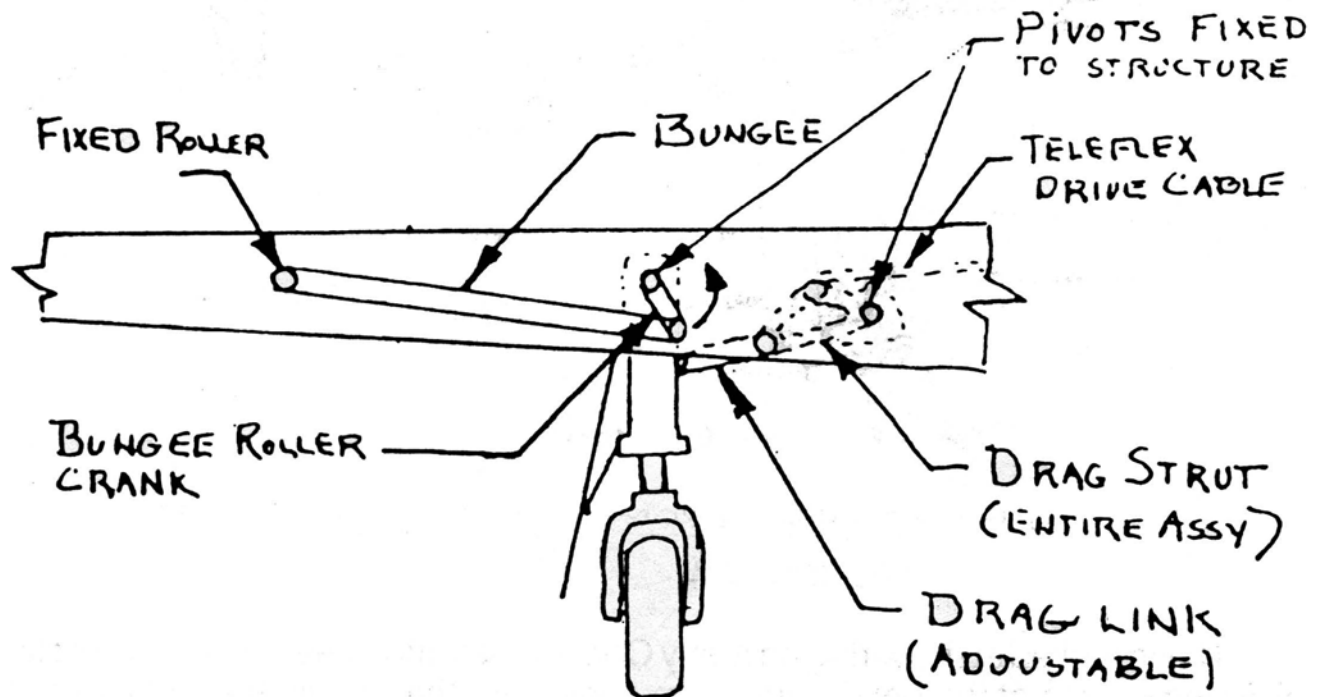
SKETCH "A"
Looking Forward Left Wing
Gear Down -- Bungee Crank Correctly Installed

Notice in sketches "A" and "B" that the bungee tension is increased until it goes over geometric center (approximately 45 point of travel) then it begins to assist the gear in its direction of travel either up or down.

Now I recommend that Dick remove the under wing bungee cord access cover of his Comanche and check to see that the bungee roller crank is positioned as shown in Sketch "A". If it is positioned as shown in Sketch "C" he should get it into his favorite Comanche mechanic without delay because when new bungees are installed he may get an open circuit breaker when he tries to cycle the gear down on the first landing attempt after new bungees are installed. I know of three such incidents including my own little sweetheart, N6734P. It took two men with shoulders against the back seat using their feet to get the gear down with a full blown airport alert at Burbank in my case. The other two were less fortunate and made wheels up landings.

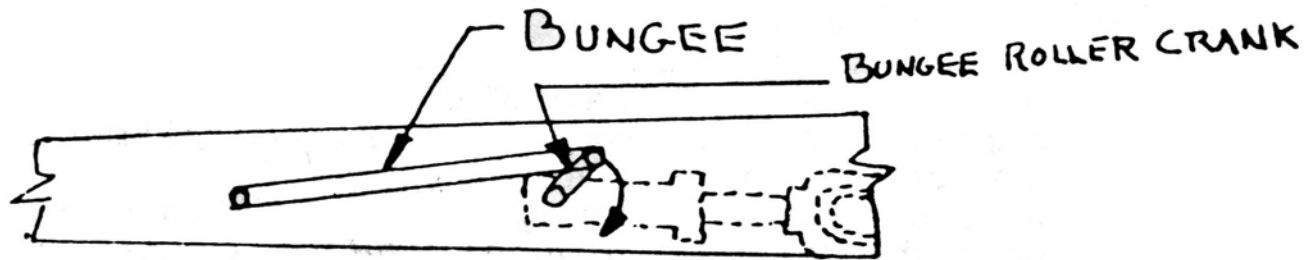
SKETCH "B"
 Looking Forward Left Wing
 Gear Up -- Bungee Crank Correctly Installed

Sketch "B" shows the bungee roller crank in the correct position when the gear is up with an arrow showing the direction of rotation when the gear is cycled down.

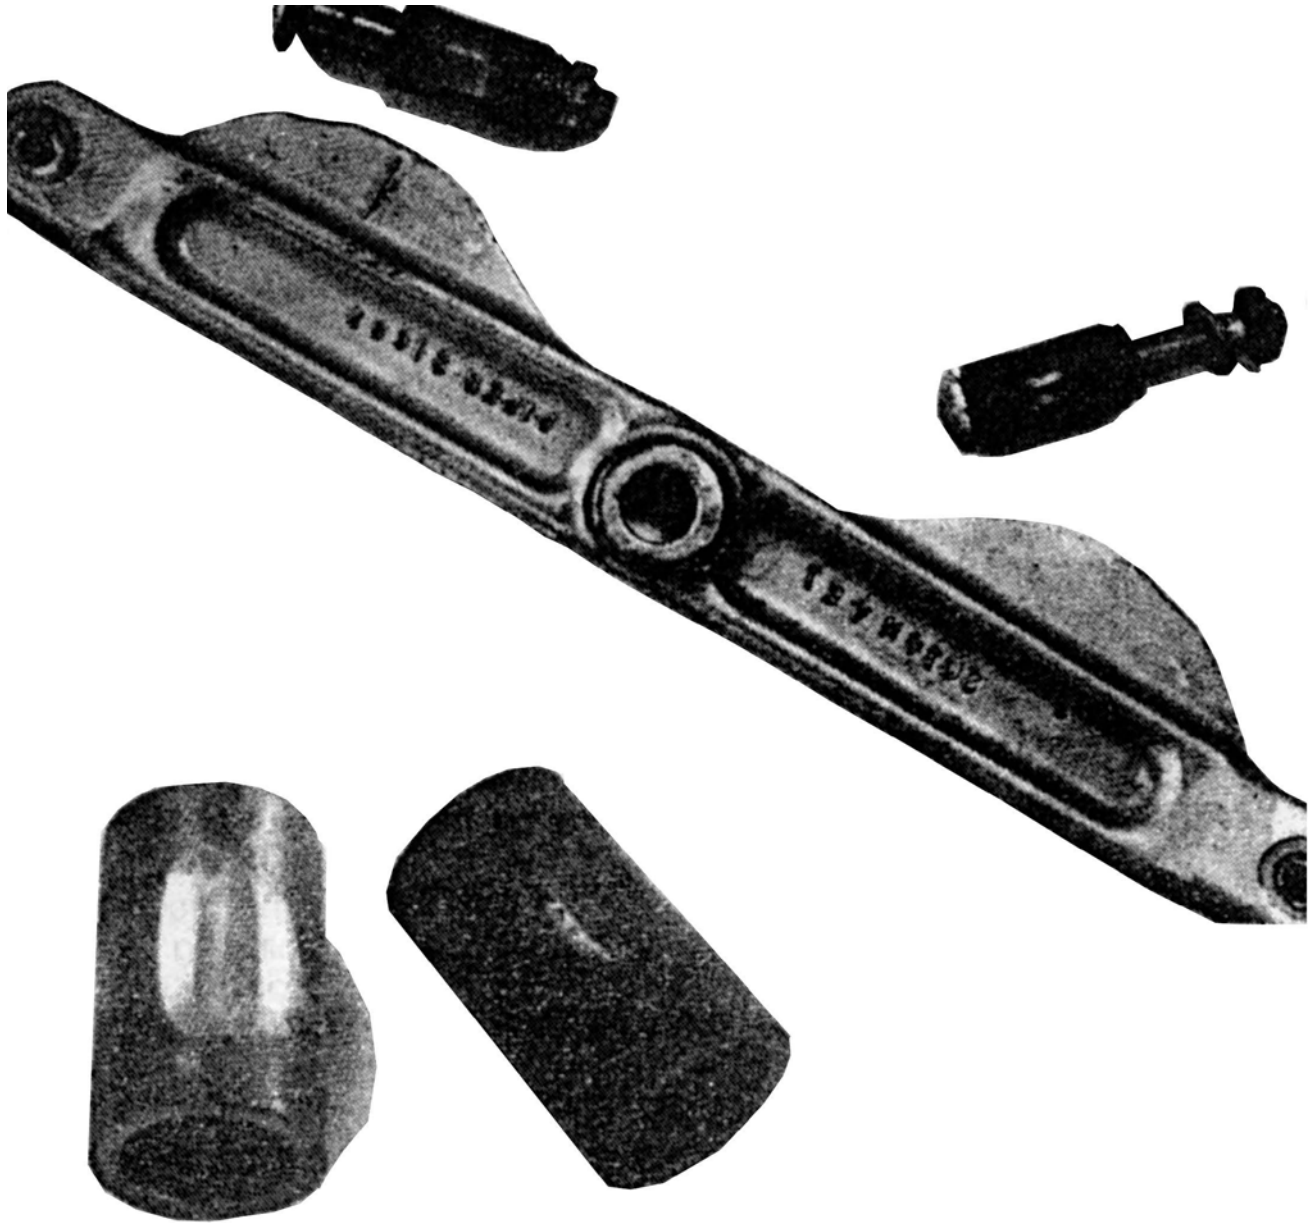
Items overlooked in a series of cheapie annual inspections have a way of snowballing and becoming (ultimately) very expensive. A case in point: When I took my first hard look at my Piper Comanche (a 180 model), I discovered that the nose gear steering bellcrank (Piper P/N 21768-00) showed evidence of peening on its cam faces. If you'll look at the accompanying photographs, you can see the distinct wear points on the cam(s) and on the steering arm bushings (Piper P/N 14976), which were worn to hourglass shapes and showed evidence of not turning. The steering arm bushings function as rollers on the bellcrank's cam faces.

According to the Piper Comanche service manual, these bushings ought to rotate with a slight drag. The book actually calls out several dash numbers of the part, representing several diameters, which can be used to obtain proper adjustment.

It is evident that as wear of the bushings progressed, the excess clearances were enough to allow peening or hammering of the cam faces due to increased play in the nose steering. A couple of my otherwise inexplicable swerves on the runway are readily excused on the basis of this wear. Less explicable is the ongoing lack of inspection and maintenance during the 23 year life span of the all consuming "period piece" that I bought to fly (and maintain!) as a hobby. Thanks to years of oversight and neglect, I had to remove the abused pieces and suffer an inordinate assault on my cash flow for the machinists spent five hours setting up the bellcrank (and five minutes to do the actual cutting) because of the need for the bushing rollers to follow

both cam profiles, simultaneously, without binding. Also, I spent a couple hours on a lathe cutting out new oversize bushings from 4130 steel bar stock.

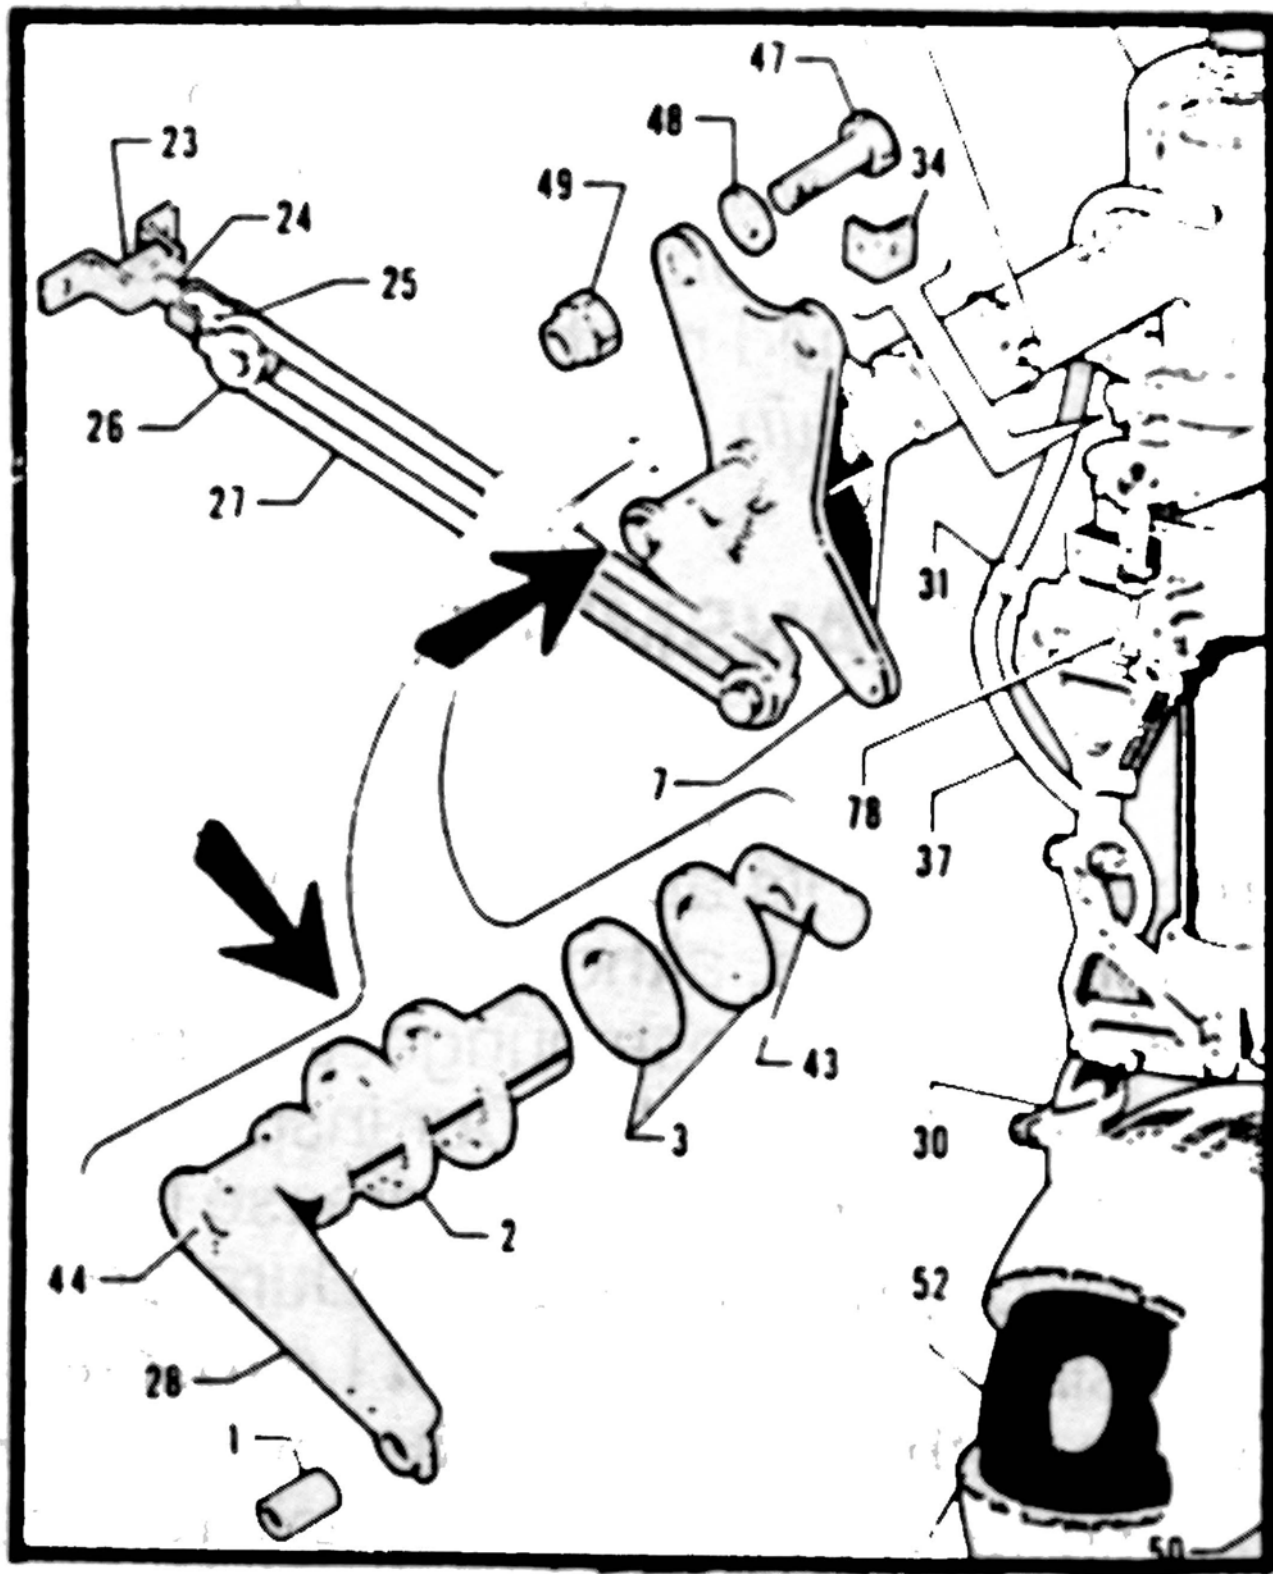
The newer arms have thicker walls even though they carry the same Piper part number.

I really question the FAA's decision of bushings being the culprit of gear up problems; rather suspect the gear transmission and this gear arm to be the main problem.

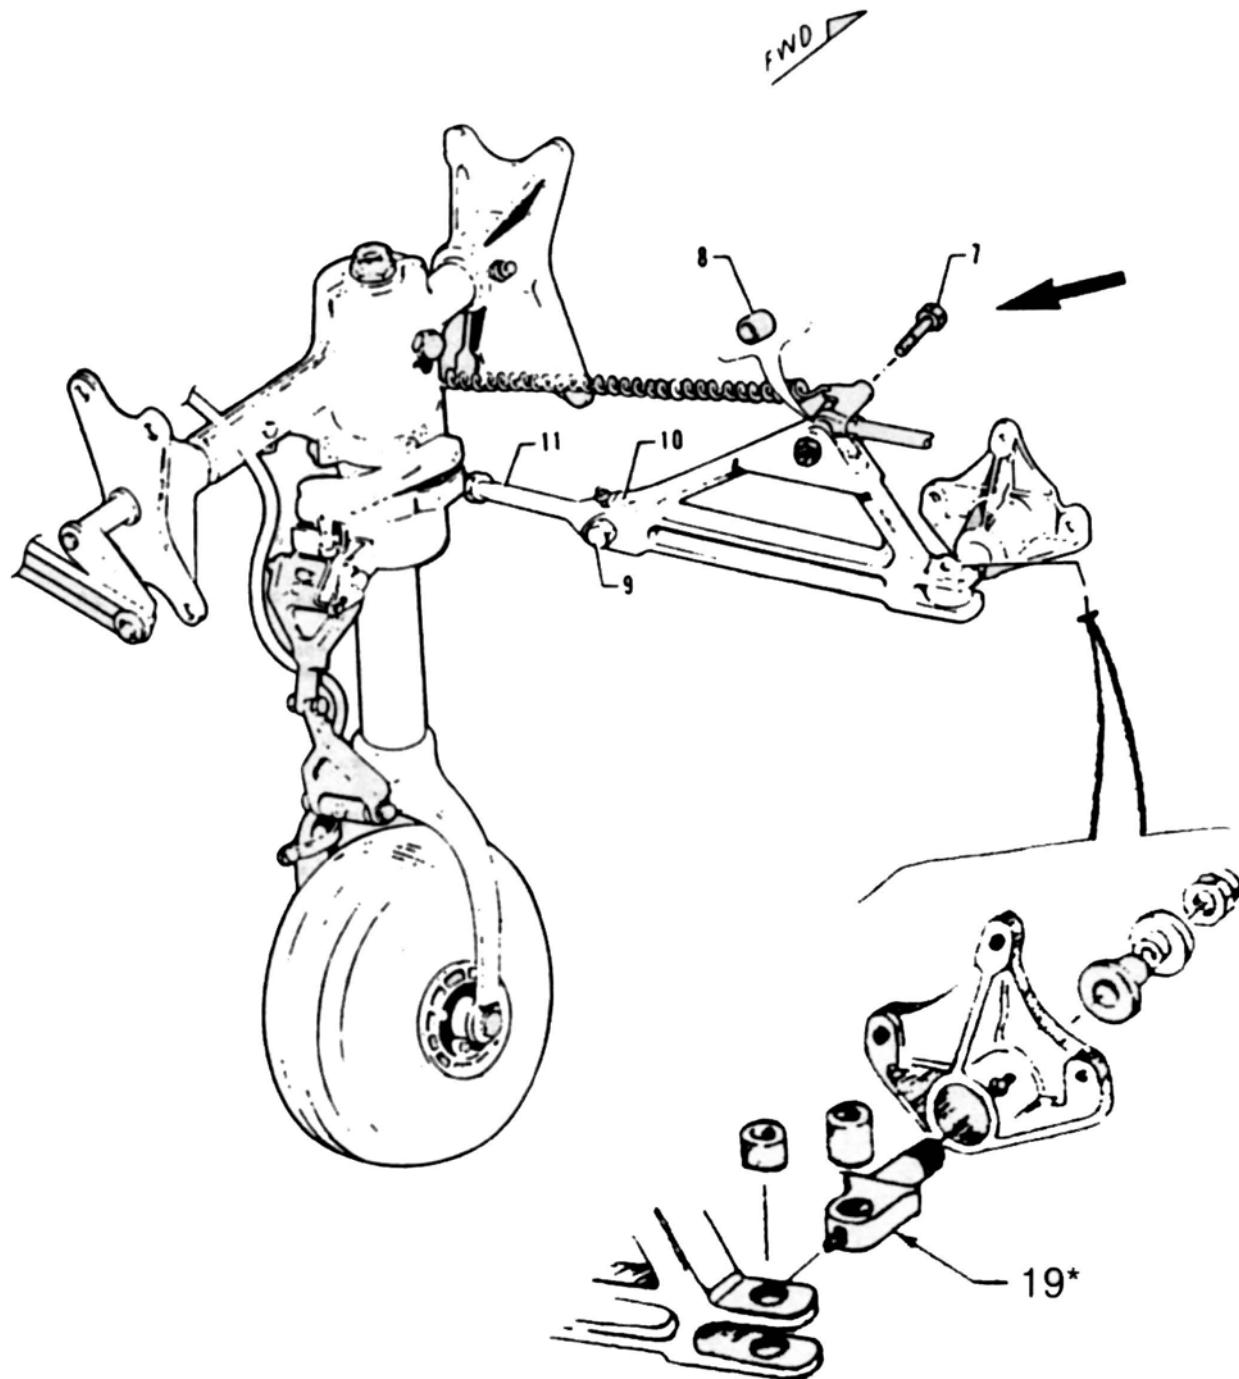
We have another item which you or your mechanic will need to check. We have found the bolt (item 7) installed the opposite way to that shown in the drawing. This will permit the end of the bolt to dig into the spar web as the gear goes up and down. It can destroy the spar. This bolt must be installed as shown in the drawing, i.e.; head forward, nut aft.

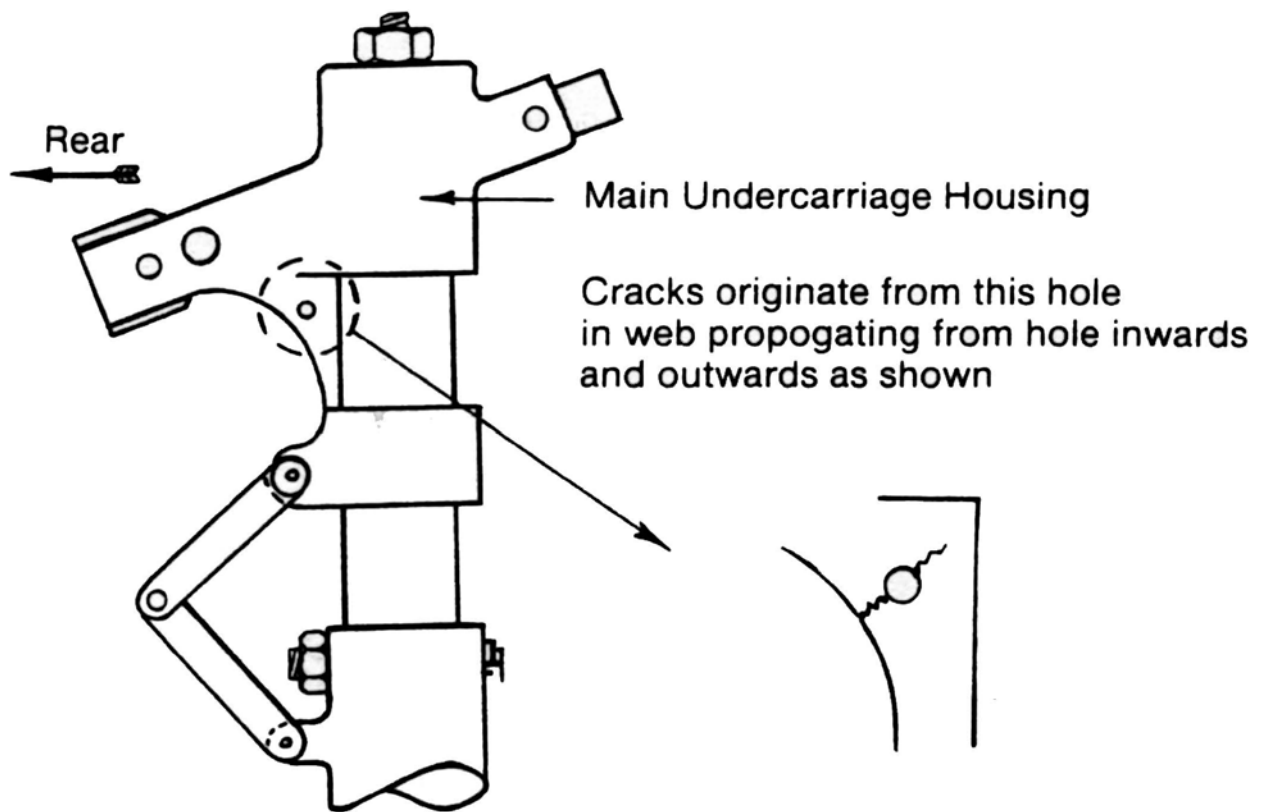
There are continuing incidences of cracks in Comanche main landing gear housings. To check for cracks, remove the bolt securing the clamp and slide clamp clear of web. Clean area in vicinity of hole and inspect for cracks visually with 10X magnifier or dye check. If no cracks are found, modify hole and web as indicated.

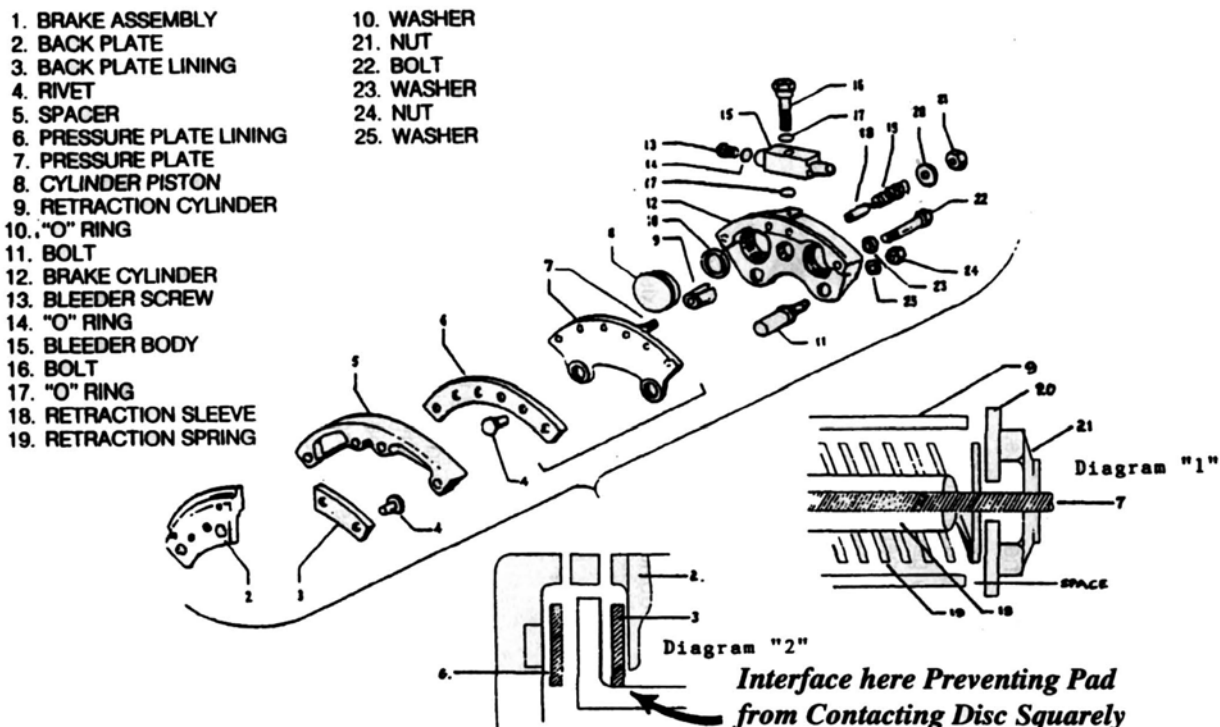
**FIGURE 6-28. BRAKE ASSEMBLY (CLEVELAND) PA24-180 and PA24-250
Serial Numbers 24 -1 to 24 - 3295**

When tightening the back plates down, make sure the tire can roll freely at all times. The back plates have pads mounted on them with three rivets each and are tightened down with 1/4" bolts that have 7/16" heads. If the brakes lock, look for this possible situation. See diagram "2". Now that everything is tightened down, go inside the plane and push on the brake pedal several times. After the second or third push, the pedal should get noticeably harder. The cylinder pistons are moving out and the retract cylinder is being pulled into position. The tires should roll easily when the brakes are released - this is the reason for the space between the washer and the end of the retract cylinder. I hope this procedure will help some Comanche owners who have always had "sticky" brakes.

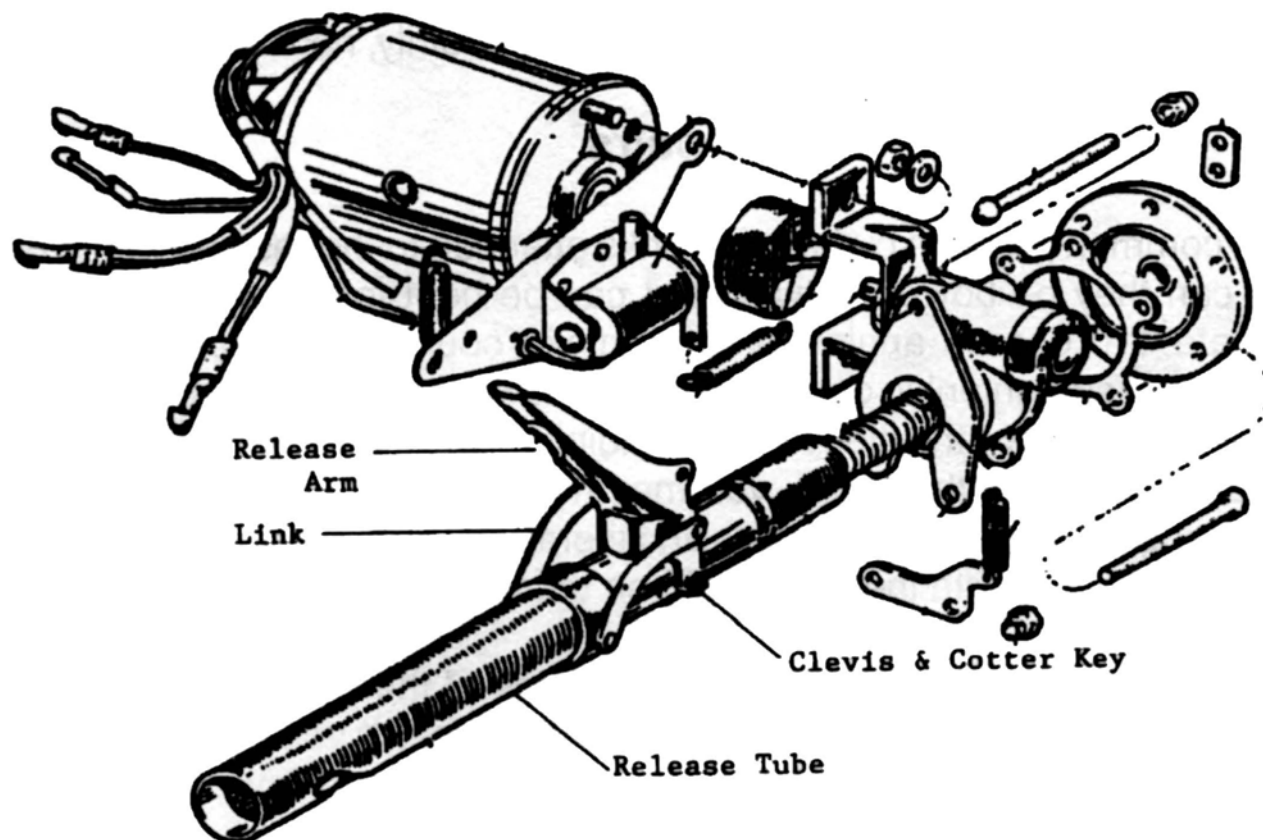
Although I realize that other things can go wrong with this mechanism, I have encountered two particular problems in my twin Comanche emergency gear release that I think ICS members should be aware of. I have found both situations: bent links and a missing cotter key / clevis pin on the emergency release arm.

1. The next time you get in your Comanche, pull up the emergency gear extension door in the floor and look at two things: the links attached to the red emergency gear release arm and the clevis pins which hold the release arm assembly on the drive shaft.

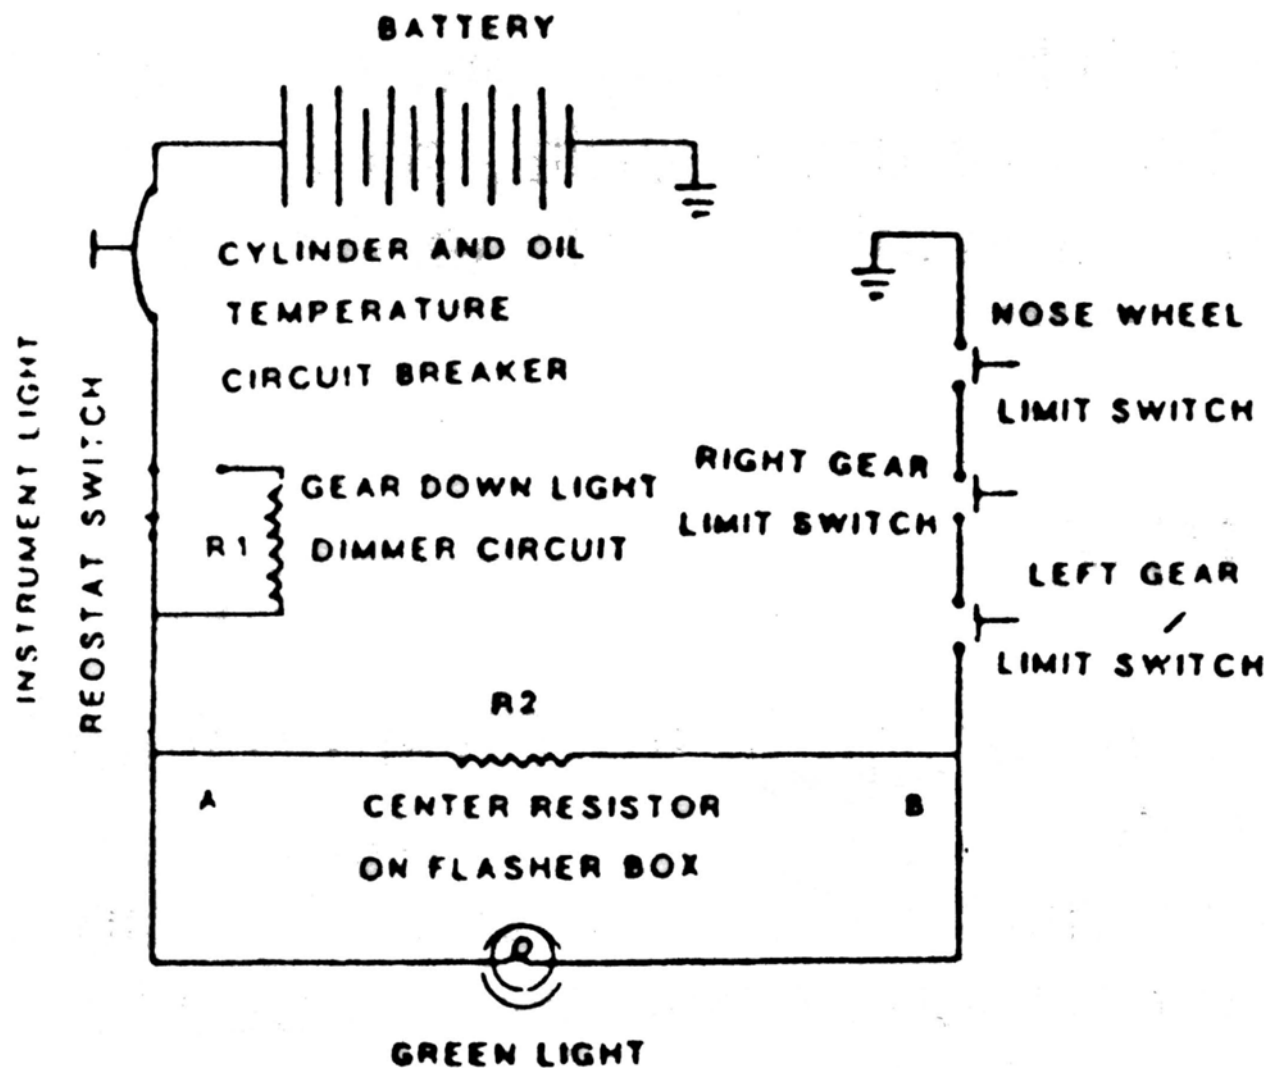
The circuit is fairly simple. Power for the green light comes from the cylinder head temperature and oil temperature circuit breaker. This enables the green light to function with the gear motor circuit breaker popped. The next item in the chain is the green light dimmer portion of the instrument light rheostat and switch. With the instrument light switch on, the resistor (R1) is in series with the green light, then the green light is dimmed for night operation. R2 is a resistor that is in parallel with the green light. The resistor provides current flow through the circuit when the light bulb is burnt out. The resistor (R2) is located in the center of the flasher box under the nose cowl (PA-30/39) on the member where the voltage regulators are attached. R2 is the center resistor. The green light socket is insulated from the instrument panel with insulating washers. If these break down, the light will burn any time the master switch is on. A chain of gear limit switches provides the ground for the green light.

From the diagram, one can see if a wire were to be used to jump from A to B briefly, the light should go out and the circuit breaker will pop. If we jumped from A to B briefly with a wire, the light would come back on if the system was spiked with the master switch or the instrument light switch. Using the jumper, we induced the problem encountered in flight.

If the above trick caused the malfunction; great. If not, don't despair. If only flight will induce the problem, put the aircraft on jacks, cycle the gear and make sure the gear is functioning properly. At this time, it is a good idea to open up the emergency gear access cover and put a mark below the push-pull cable ends in the full down position. This mark will enable one to determine if the motor and transmission has moved to full travel in flight. Alignment will not guarantee that the gear is locked, but malfunctions past this point in the system are fairly rare. While the aircraft is on jacks, check the gear limit switch adjustment and the general condition of the wiring. Careful attention should be paid to the butt splices, corrosion, fit, etc.
