Tips from Comanche *Flyer* magazines Feb 1973 – Sep 2012

CHAPTER THREE

FUEL SYSTEM

(FUEL TANKS, FUEL LINES, TIP TANKS, GAUGES

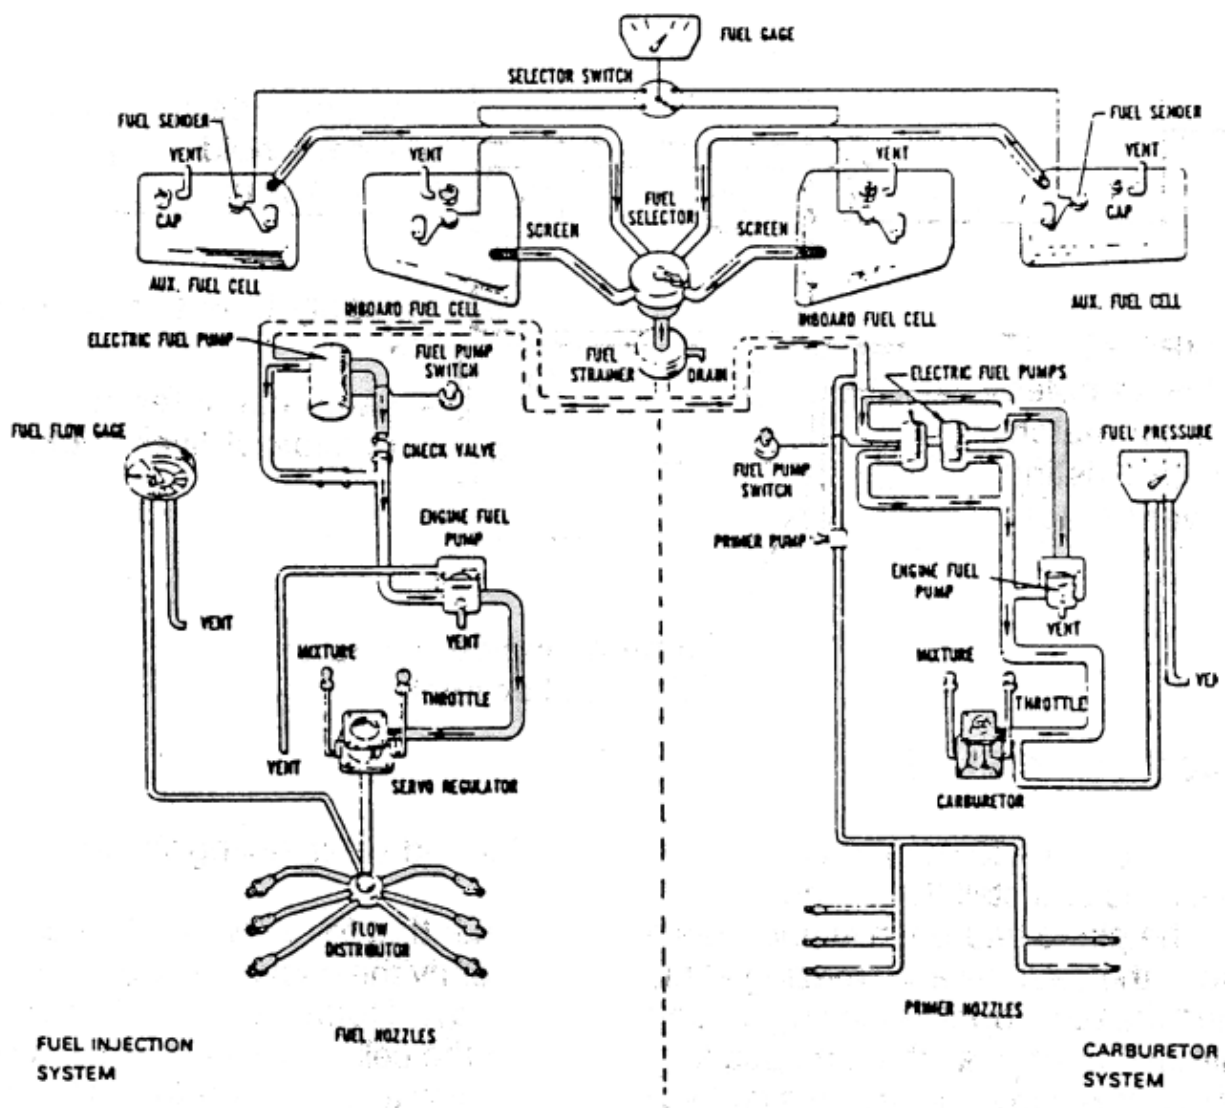
A typical Comanche fuel line schematic. Carb. models could suffer excessive fuel heat and vapor build-up in engine-driven pump and its lines when electric pumps are operated for long periods.

In my opinion, this method will prevent the very large drop or the temporary loss of fuel pressure when the electric pump is turned off after being on a long time on the ground plus a long time to altitude. However, there will be some drop in full pressure when the electric pump is turned off but no interruption of fuel flow should occur.

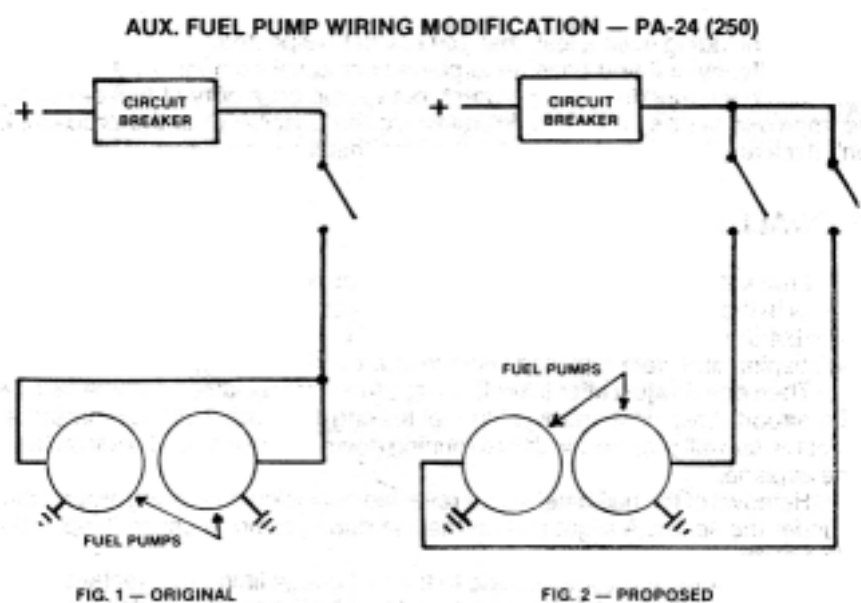
I therefore modified the auxiliary fuel pump circuit as shown on the accompanying drawing. A split type Cessna master switch fits nicely into the space previously occupied by the single aux. pump toggle switch. Since the circuit breaker is upstream of the switches, I could see only limited benefit in doubling up that part of the circuit, so left it as is.

I have a one-time approval from Transport Canada's Airworthiness Branch for this modification.

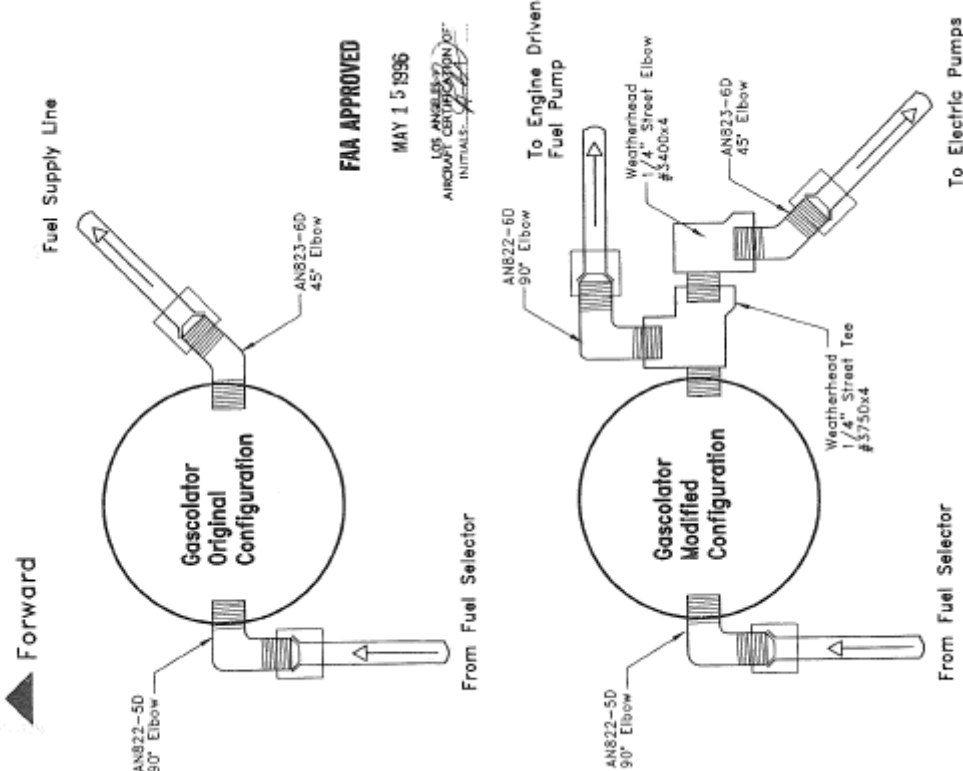
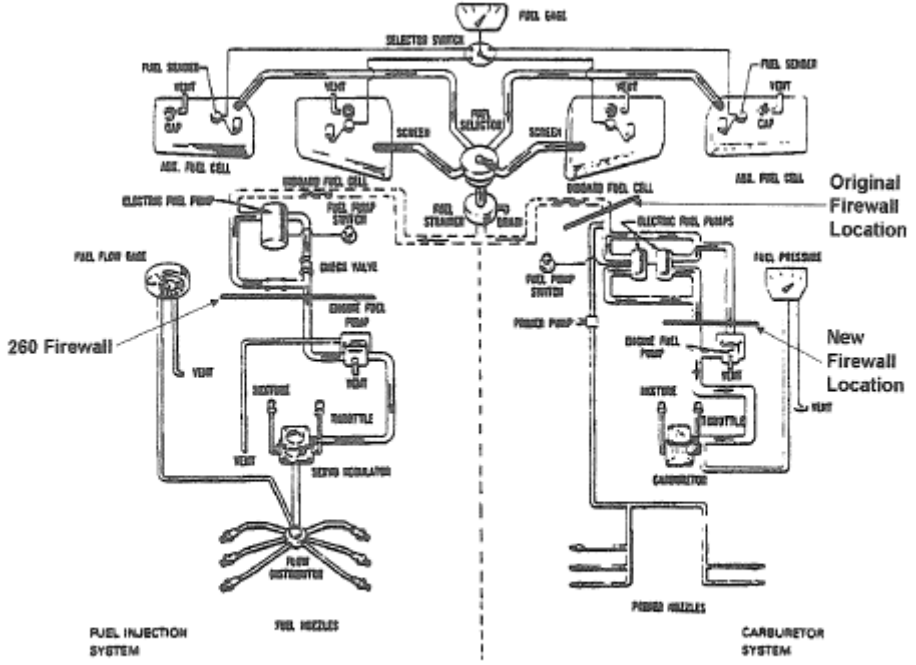
FIGURE 8-4. FUEL SYSTEM SCHEMATIC
PA-24-250, Serial Nos. 24-2299 and up and PA-24-260
FUEL SYSTEM ISSUED: 8/18/72

Fuel Pumps and Fittings As Mounted On Right Stringer Of Gascolator Compartment

**New Fuel Pumps Relocated
In Gascolator Compartment
Are Easily Accessible**
