TIPS – Chapter Seven

Landing Gear and Brakes

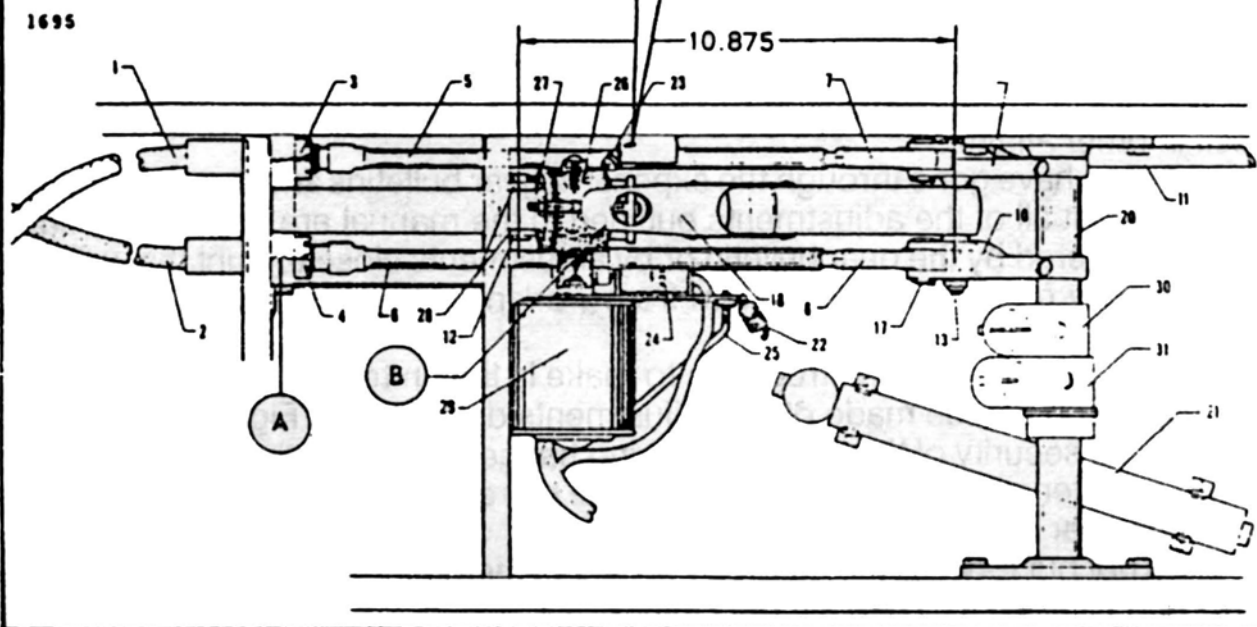
SKETCH B

My clever use of this strategy had sheared two pivot (clevis) pins in the release lever, torn off the brake assembly and jammed the jammed actuator on through its jammed position and let the

Popping a breaker is small irritation, but it is no big deal as long as the emergency extension system works. The transmission, motor and actuating screw is spring loaded by the retracting spring (23). When the release lever is released, the retracting spring holds the whole mess up so it won't jam as mine did. This retract spring is held on the unmoving end by a cotter pin through the floorboard of the plane near the lower left corner of the opening. Piper noted on the drawing that the cotter pin should be adjusted as to allow the end of the retracting spring to be suspended .62 from the top of the floor board. I guess they meant for this to be interpreted to be 620 thousandths of an inch with no plus or minus tolerance – or that it simply was not critical since such close calibration of a cotter pin could be somewhat demanding for us ordinary people. On my airplane the cotter pin had been pulled through the floorboard and had more than one inch below the floor. This slack allowed the end of the retracting spring to unhook and fall off. For lack of support of this spring the release lever jammed under the torque tube.

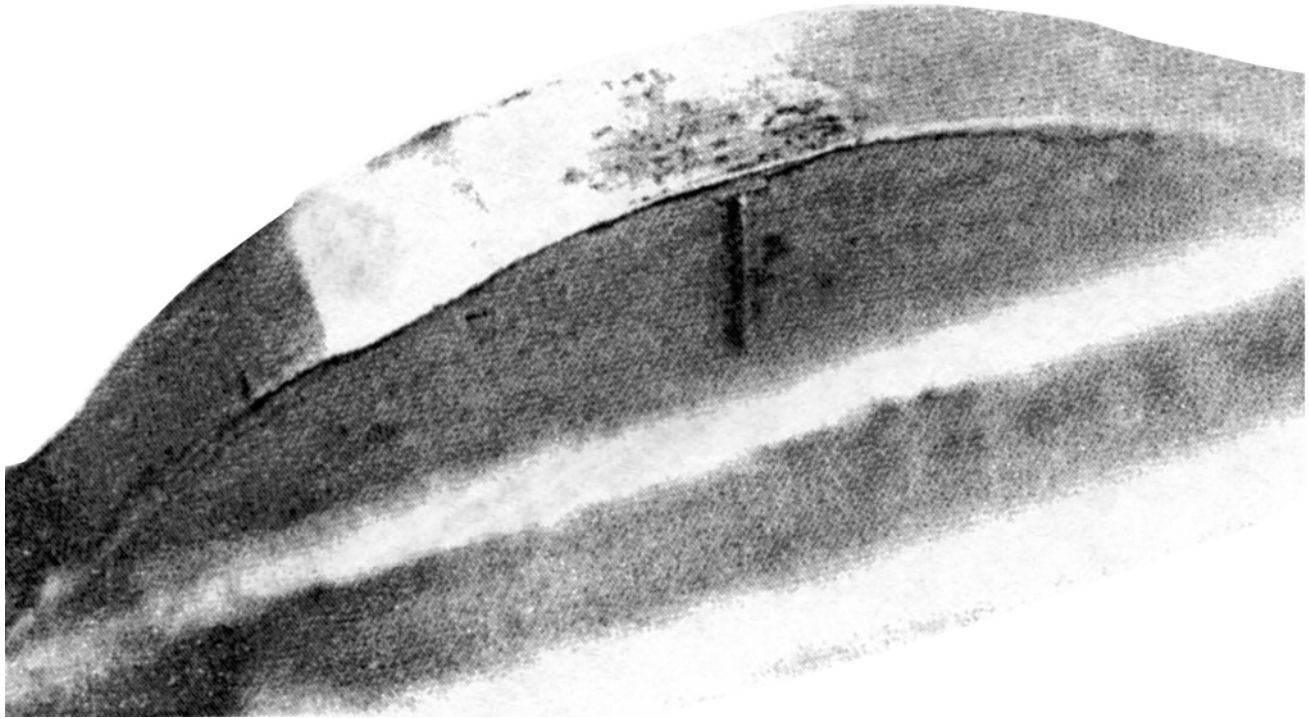
It is evident that as wear of the bushings progressed, the excess clearances were enough to allow peening or hammering of the cam faces due to increased play in the nose steering. A couple of my otherwise inexplicable swerves on the runway are readily excused on the basis of this wear. Less explicable is the ongoing lack of inspection and maintenance during the 23 year life span of the all consuming "period piece" that I bought to fly (and maintain!) as a hobby. Thanks to years of oversight and neglect, I had to remove the abused pieces and suffer an inordinate assault on my cash flow for the machinists spent five hours setting up the bellcrank (and five minutes to do the actual cutting) because of the need for the bushing rollers to follow

These parts, incidentally, are common to all PA-24, PA-30, and PA-39 airplanes. Curiously, the steering bellcrank was stamped Piper 21687, while the parts book calls out P/N 21768-00.

both cam profiles, simultaneously, without binding. Also, I spent a couple hours on a lathe cutting out new oversize bushings from 4130 steel bar stock.

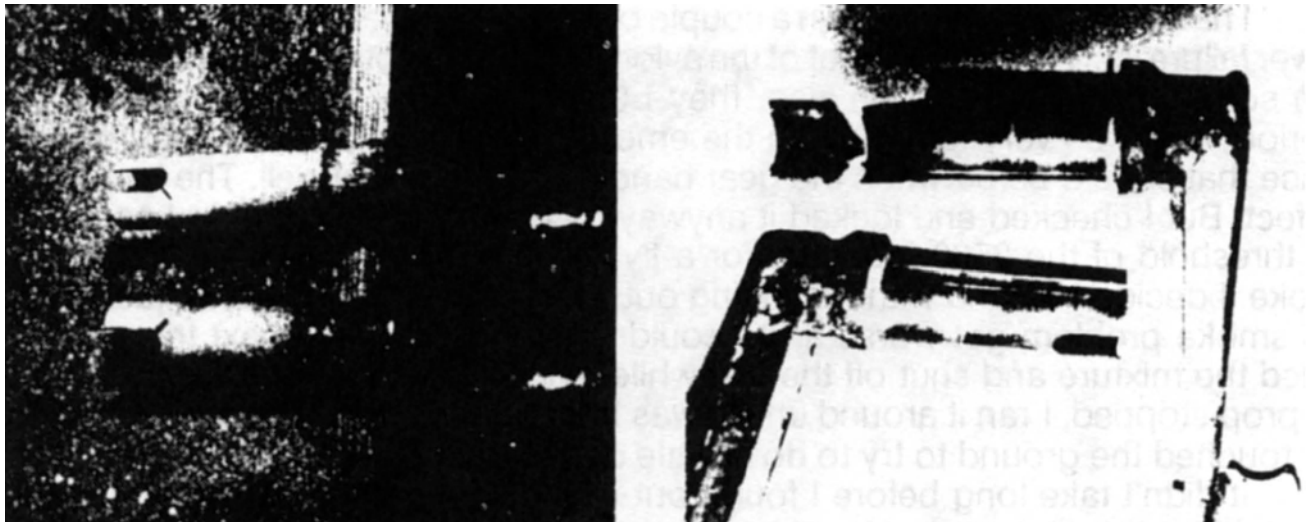
1. The left one will go on the right side – the arm then is in the wrong position.
2. The arm can be rotated approximately 180 and it will go on. Again, the arm is in the wrong position.
3. The right way – When viewed from behind (through the opening where the bungee is housed) and with the left gear in the full down position, the bungee arm should be at approximately a 4:30 to 5:00 position. On the right gear, the arm should be at approximately 7:00 to 7:30.

These arms can be obtained from Av-Pac by calling (800) 228- 1836. Bob Weber of Webco Aircraft Services also has these parts available. If you order a replacement arm, you will get #20846- 06 for the left and #20846-07 for the right. These will be the heavy walled ones that are on the 260's, the 400's and the twins.

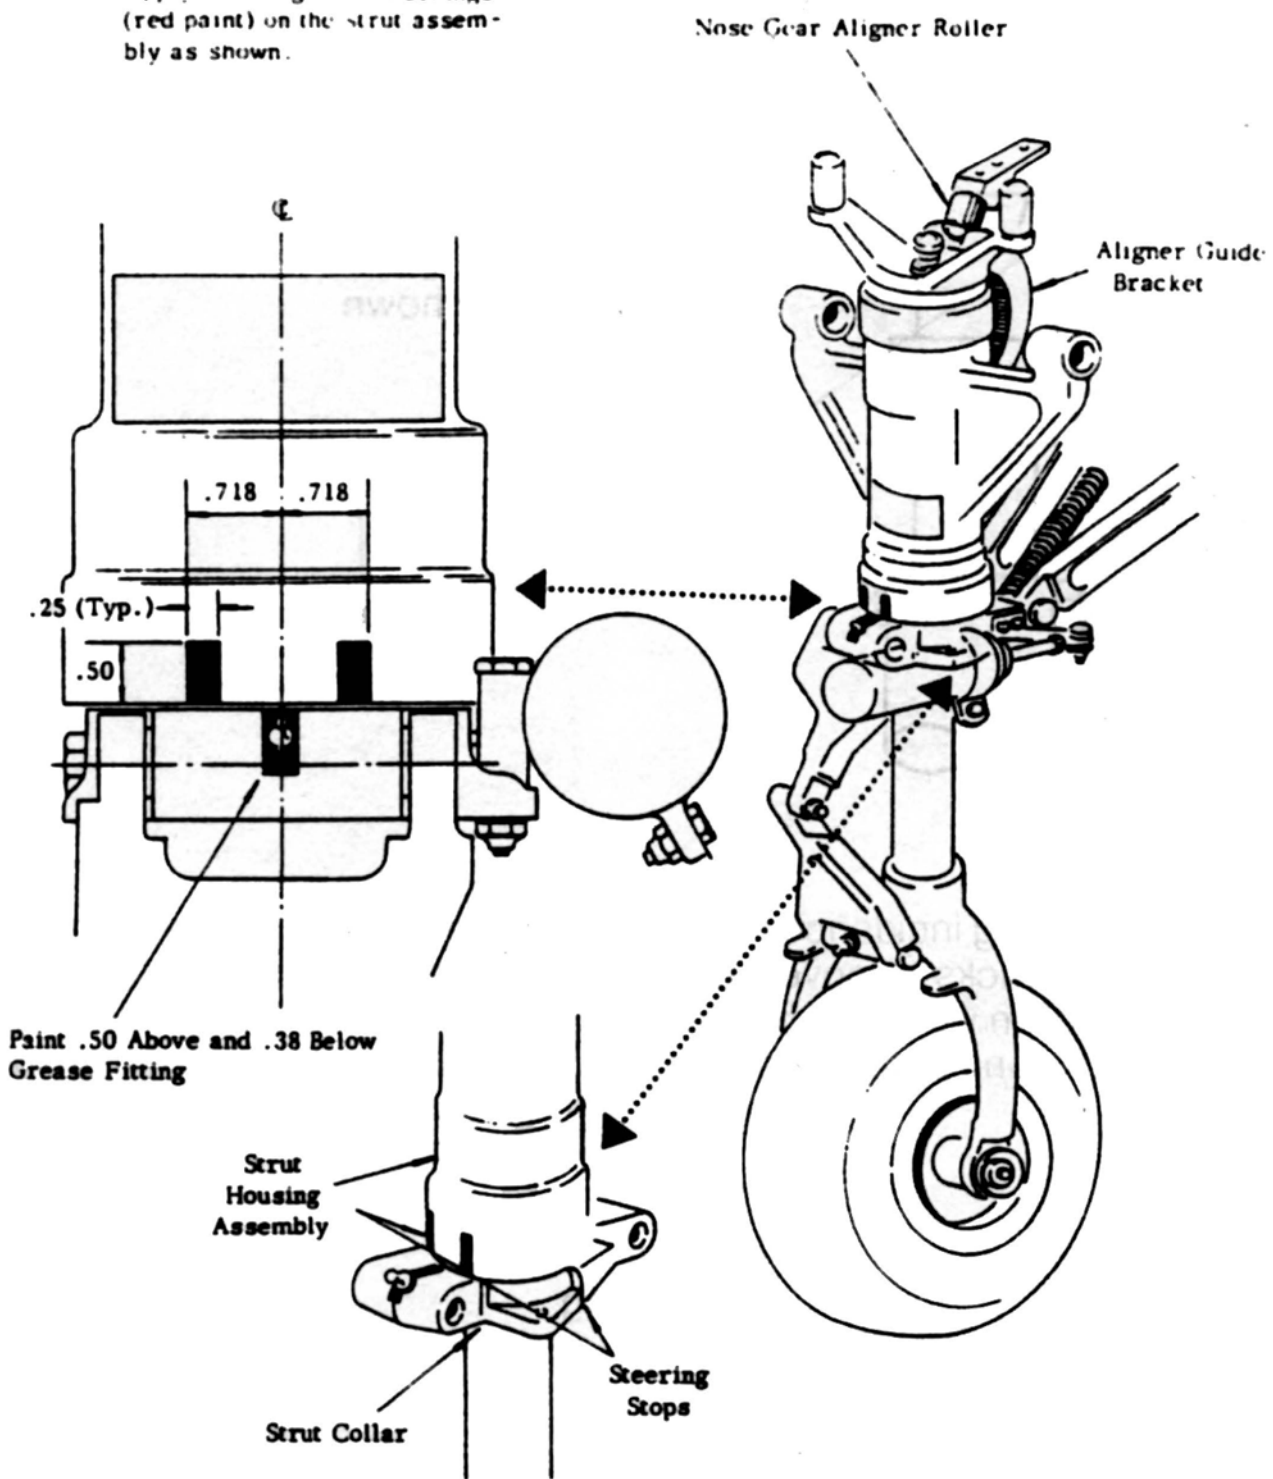
Service Letter No. 575

There are steering limit markings painted on the gear, but usually the person on the tug is either ignorant of this, or not interested. If your Comanche has been parked by someone other than yourself, I suggest you inspect it very carefully before you start it. This service letter applies to the twin, but the information is basically the same for all of our aircraft, both single and twin models. Piper service letter 575 follows for your information.

3. Perform a minimum of two (2) gear retraction cycles: one with rudder pedals completely depressed full left, and another with rudder pedals completely depressed full right. During gear cycling, observe that the aligner roller is engaged within the gear aligner guide bracket channel (reference attached sketch for a pictorial description).
 - a. If the aligner roller does not engage within the aligner guide bracket during gear cycling as specified above, it will be necessary to readjust the nose gear steering travel limits.
4. Apply steering limit markings on the nose gear strut housing as denoted on attached sketch.

Note: Apply steering limit markings (red paint) on the strut assembly as shown.

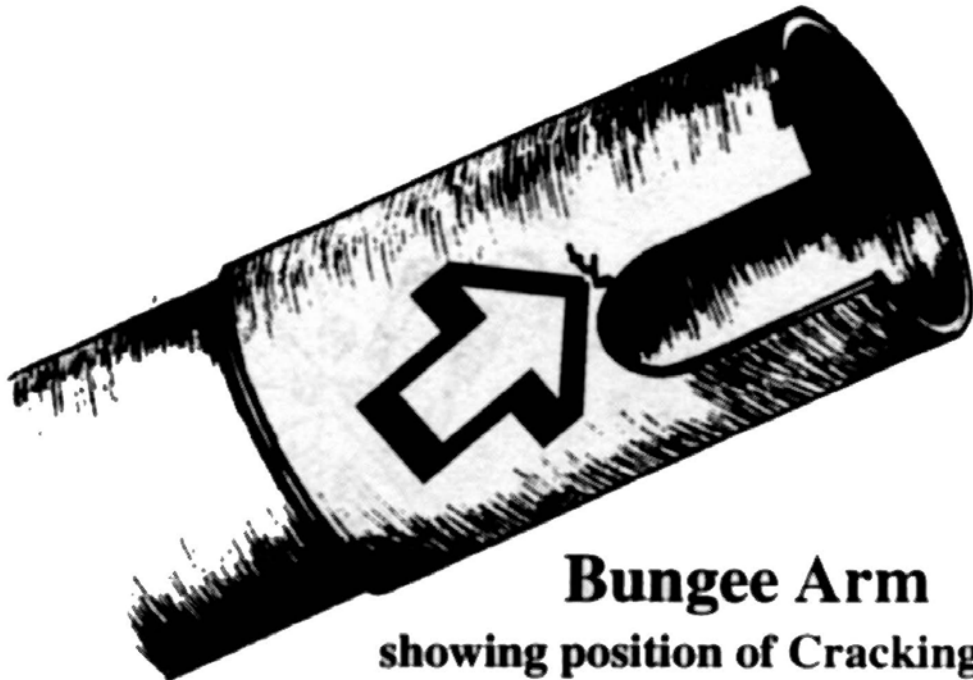
A mechanic had removed thin walled bungee arms and found them cracked and these were replaced with new thin walled arms. I assume the crack was at the point shown in the drawing below.

The thin walled arms were found only in the 180's and 250's. The thin walled is 0.062 and the heavy walled is 0.125 as found in the rest of the Comanche fleet. I am puzzled about the thin wall replacement as back in the mid '80's, if you ordered the proper part number from the parts book for a 180 / 250, you would automatically get a heavy walled bungee arm as Piper no longer made thin walled ones. If your 180 / 250 still has the thin walled arm, they should be checked every time you change the bungees. If the arm is in good shape, I see no harm in putting it back. If you find it cracked, it must be replaced. Replace it with the heavy walled unit as that is the only approved replacement part. We have talked about these arms in the past, but obviously the problem still exists.

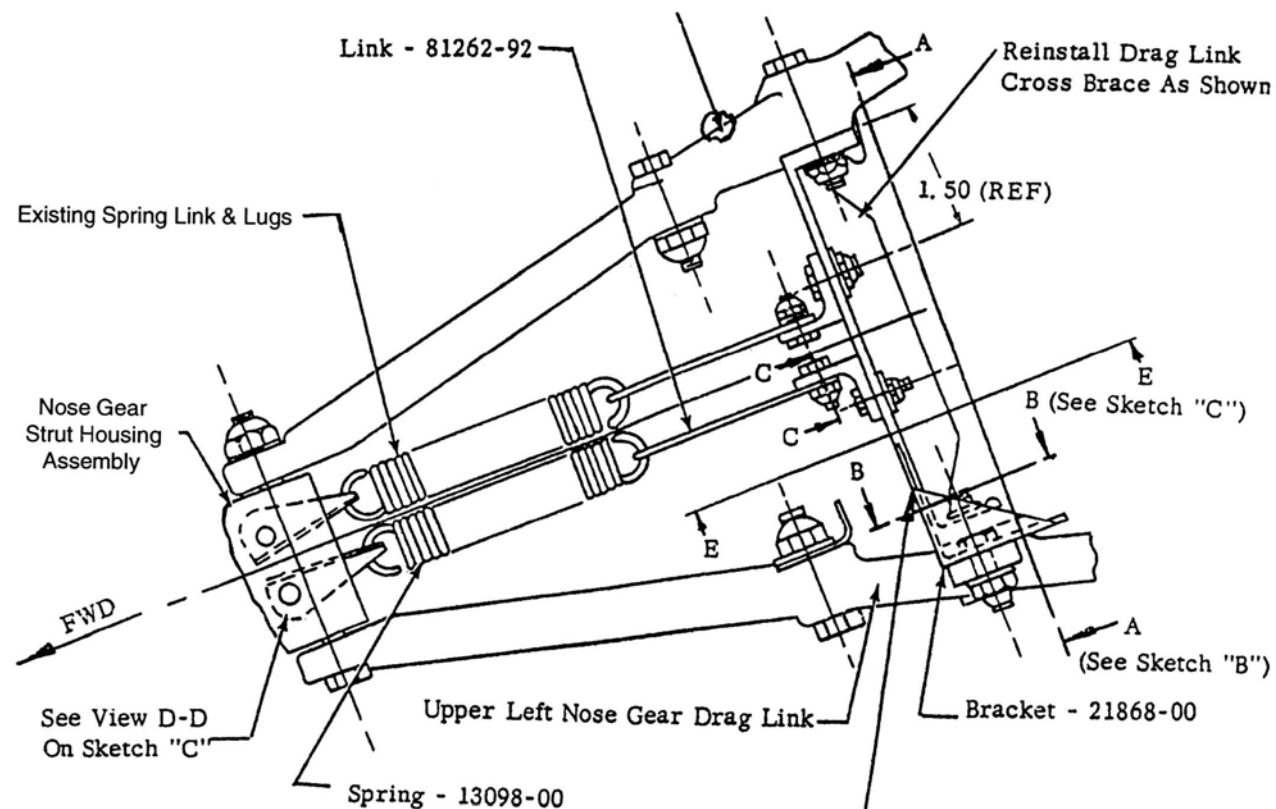
FIGURE 1
Spring Installation (View Looking Down)

I had a most interesting call from Wayne Damico ICS #12986. He just recently bought a 180 Comanche. After looking it over, he discovered that something about the nose gear didn't look right to him. The two springs on the nose gear weren't parallel to each other. My understanding is that a short time before he got the aircraft, the 1,000 hour gear inspection (Piper S/B 782B) had been C/W. The AP/IA had basically completely disassembled the gear and in putting it back together had installed the nose gear drag link cross brace backwards. Also the lugs that attach to it were on upside down. This action will make the springs (intended to hold the gear over center in the down position) do just the opposite; unlatch or pull the gear over center in the up position. Keep in mind that these springs have no effect on the gear when it's operating normally; they only come into play when the gear has been disconnected to use the emergency system.

For example, a number of years ago a member had this same inspection done then flew the airplane a year or more. Then on a trip to Mexico the gear didn't go down (at this point, I don't remember why). He put it down using the emergency method and after a short roll out the gear came up. Inspection showed that the springs were on the wrong way causing the gear to come up. If you have had the inspection done on your aircraft, look it over to be sure that everything is together properly. I want to thank Wayne for being so observant on the new aircraft. We are also showing one page from kit #761-082 so that you can see how it should look.
